Project Title: **Harmonized approach to stress tests for critical infrastructures against natural hazards**

Acronym: **STREST**

Deliverable Title: **Report on lessons learned from recent catastrophic events**

Work Package: WP2 – State-of-the-art and lessons learned

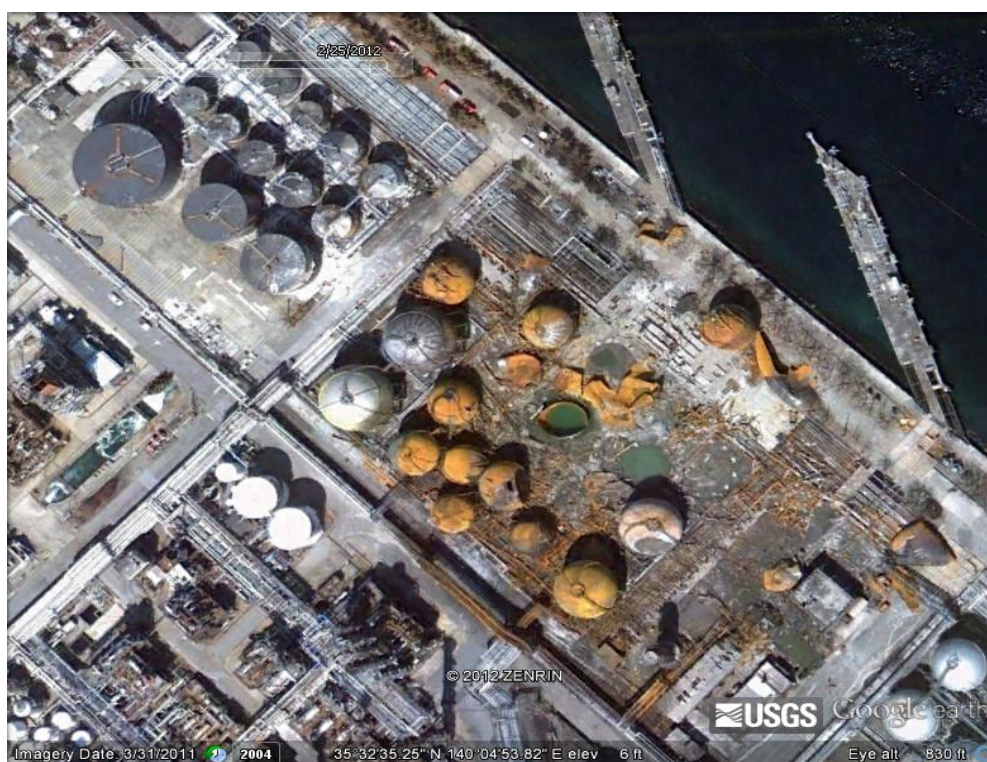
spheres, held in place by legs supported by diagonal braces. Unknown to the refinery operator, the first earthquake shock damaged the braces on an LPG tank that at the time of the earthquake was filled with water for maintenance reasons. The second shock caused the weakened braces of the tank to buckle and subsequently the tank to collapse. This ruptured the LPG pipes connected to the tank and led to the release of flammable gases that eventually ignited (Cosmo Oil, 2011a; Krausmann and Cruz, 2013). Due to heat impingement by the fire on the other storage tanks, they ruptured via boiling liquid expanding vapour explosions (BLEVE). Overall, 5 major explosions were recorded.

Fig. 2.1 The LPG tank farm at the Chiba refinery after the earthquake-triggered fires and explosions (©2012 Google, ZENRIN)

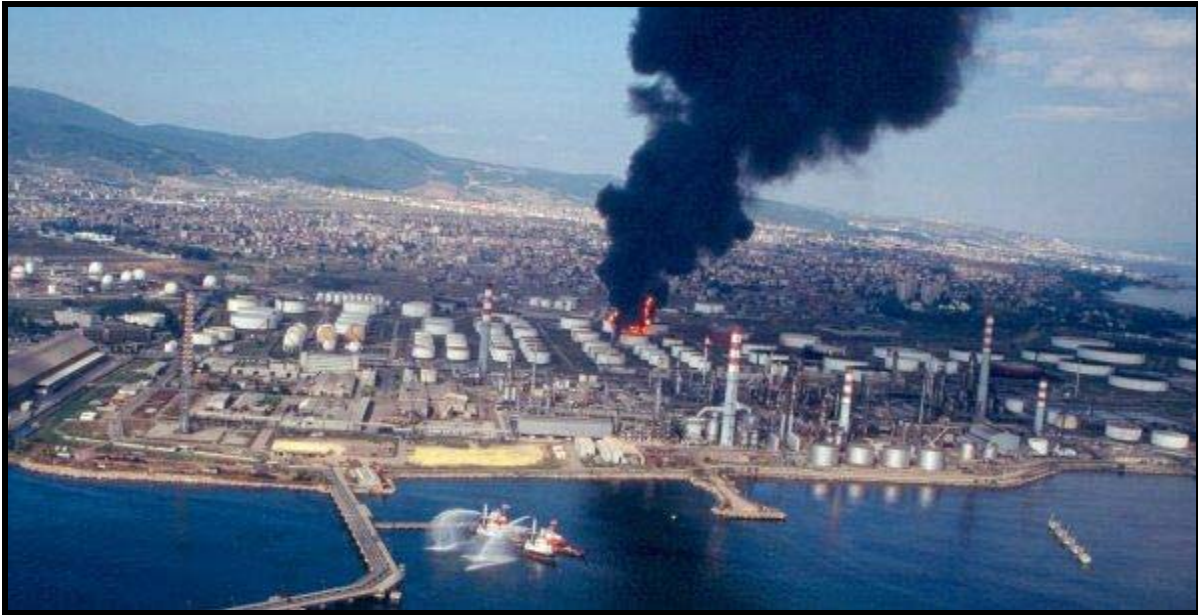
Fig. 2.3 Aerial view of the Tupras refinery after the Kocaeli earthquake

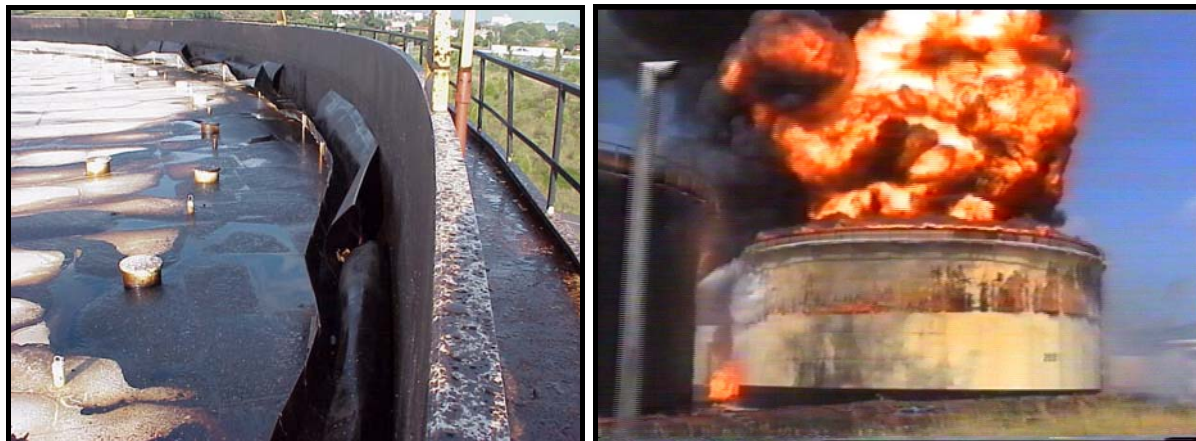
Fig. 2.4 Tank fire at Tupras refinery due to collision of the floating roof with the tank wall (Courtesy of Tupras A.Ş. (TUPRAS, 2000))

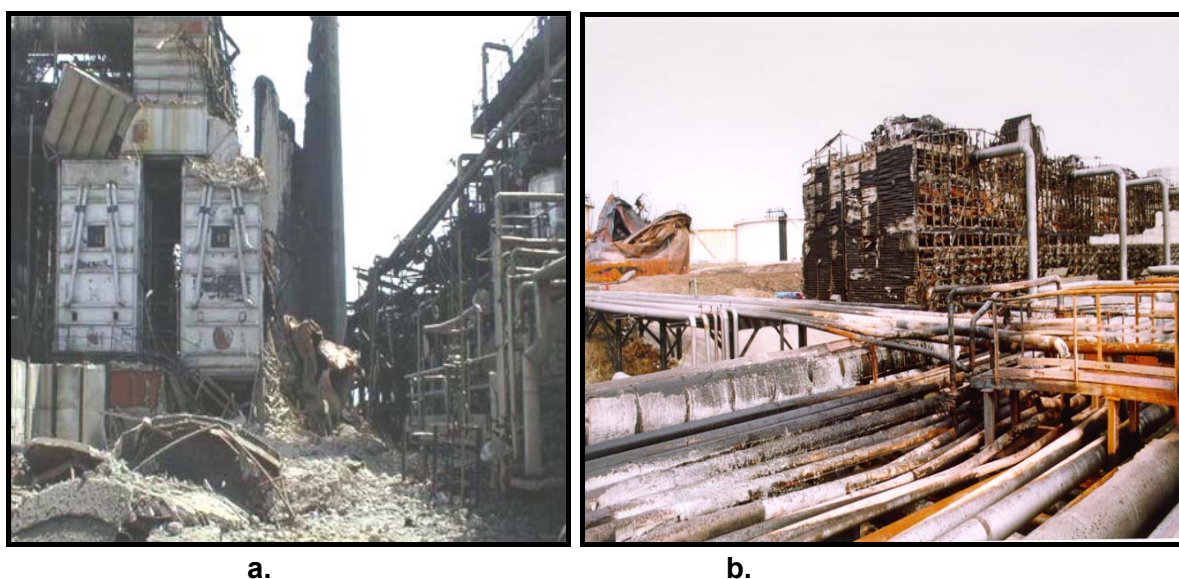
Fig. 2.5 Burned cooling tower (left) by the radiant heat of the burning tanks and damaged heater due to collapse of the stack (left) at TUPRAS refinery

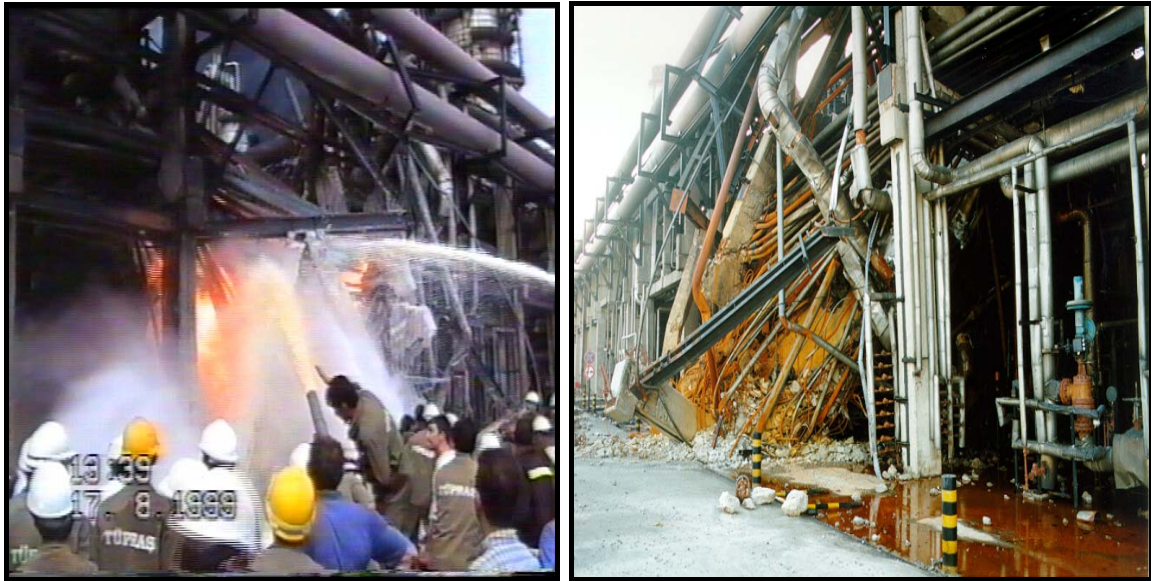
Fig. 2.6 Damage and fire at the pipe rack due to collapsed stack at TUPRAS refinery

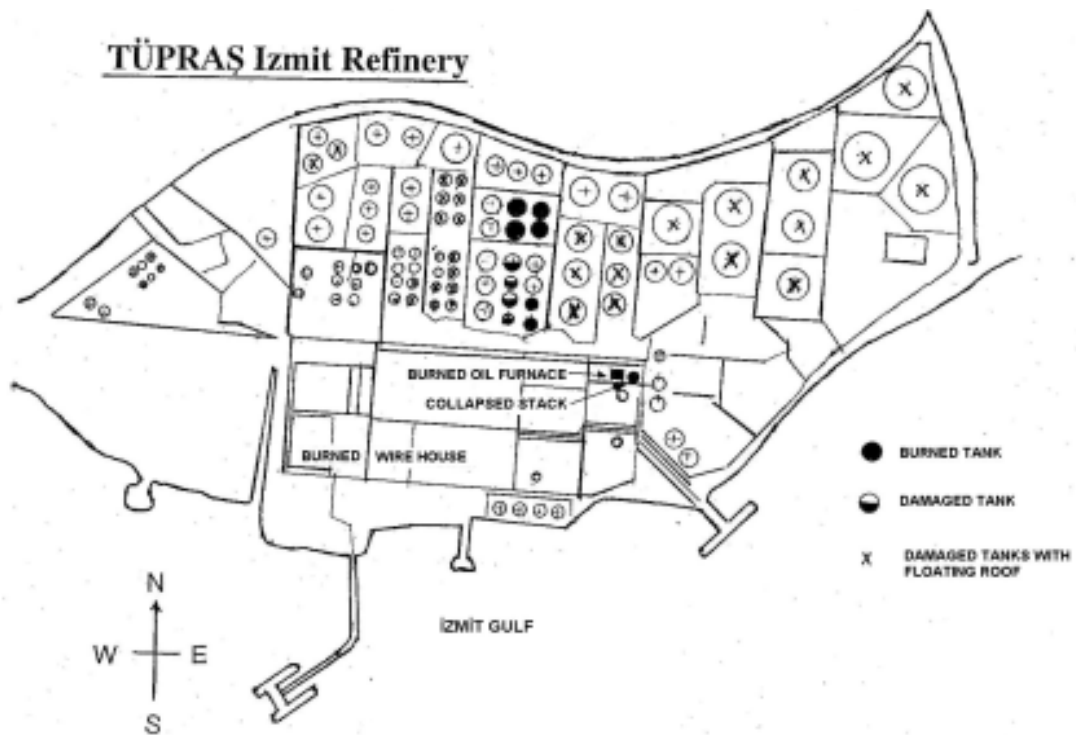
Fig. 2.7 Locations of damaged and burned tanks (JSCE, 1999)

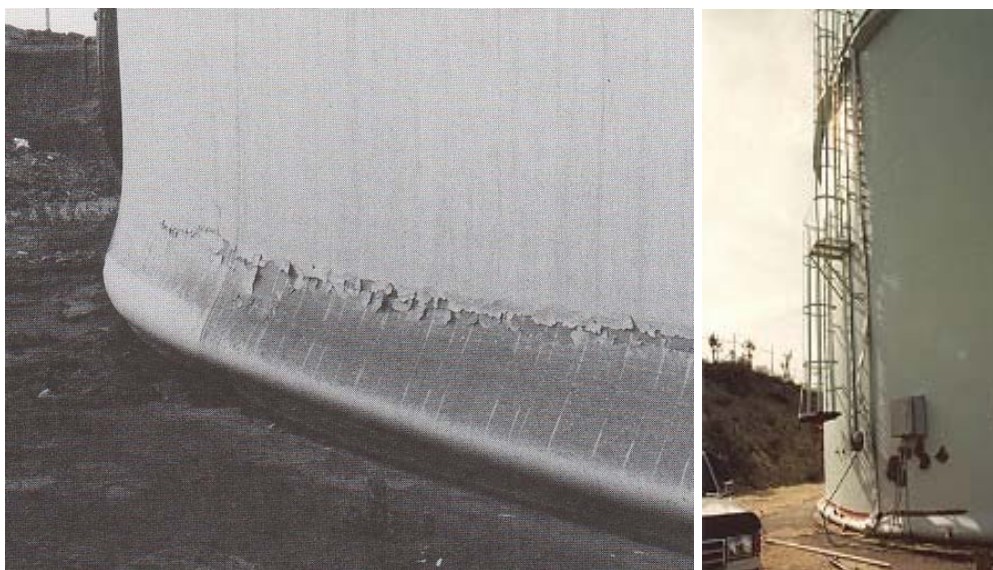
One of the fire fighting water tanks was a bolted steel tank unanchored at the base. The bolted tank failed in "elephant foot" buckling of the tank wall around its base, as shown in Fig. 2.8, whereas the welded tank anchoring system prevented any damage to the welded tank wall.

Fig. 2.8 Elephant foot buckling of a bolted steel tank

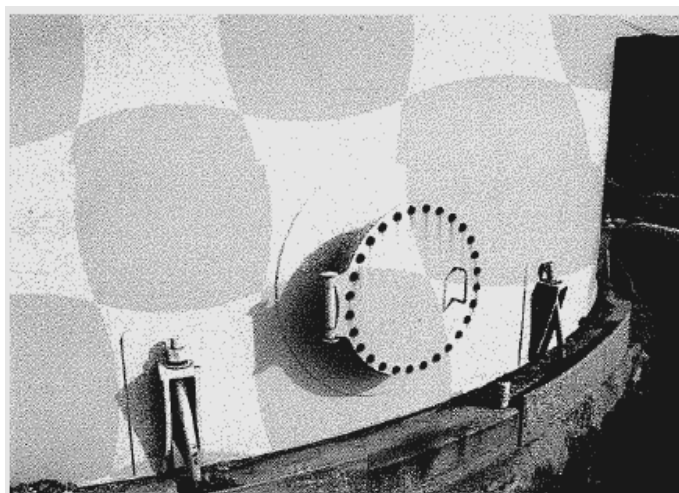
Fig. 2.9 Pulling out and twisting of the anchor bolts (Lau et al. 1995)

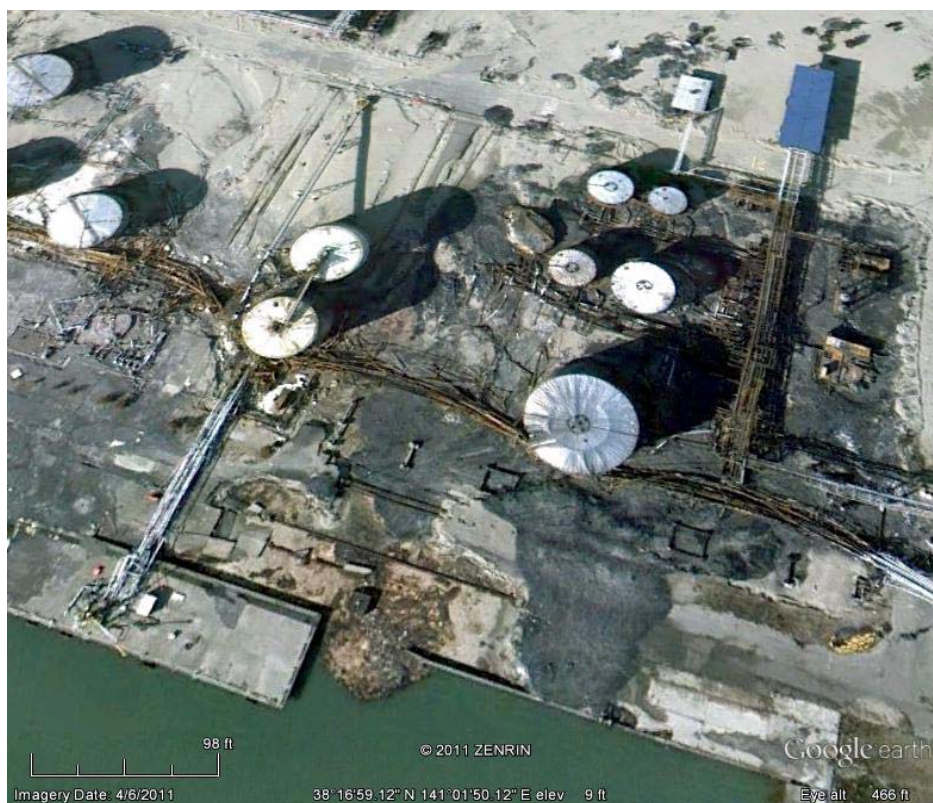
Fig. 2.10 Part of the Sendai refinery's western section that was consumed by flames (©2011 Google, ZENRIN)

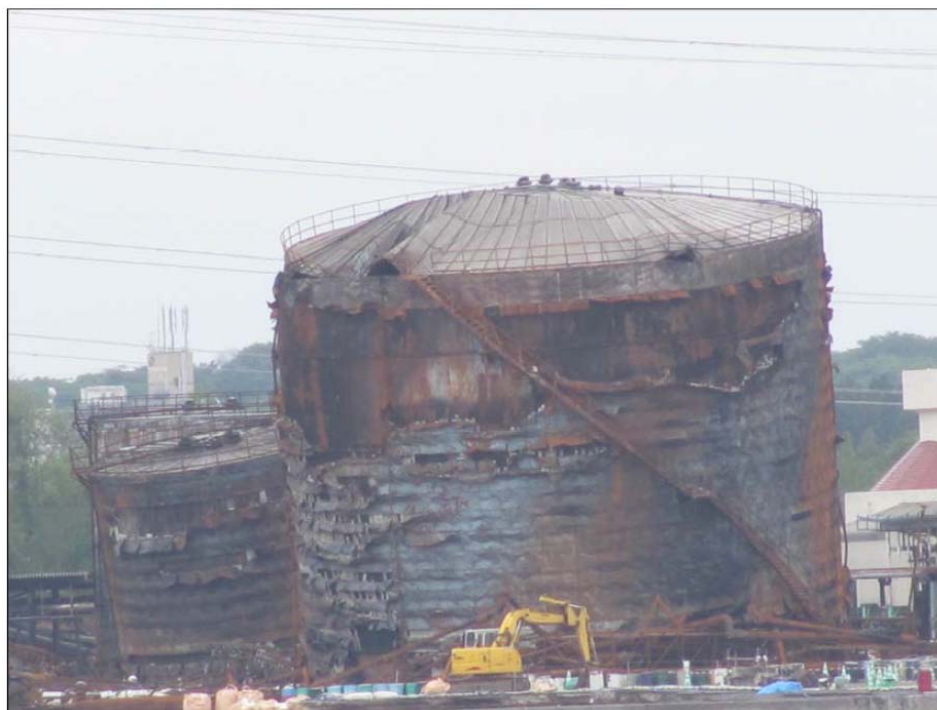
Fig. 2.11 Burned hydrocarbon tank at the JX Sendai refinery (TCLEE, 2012)

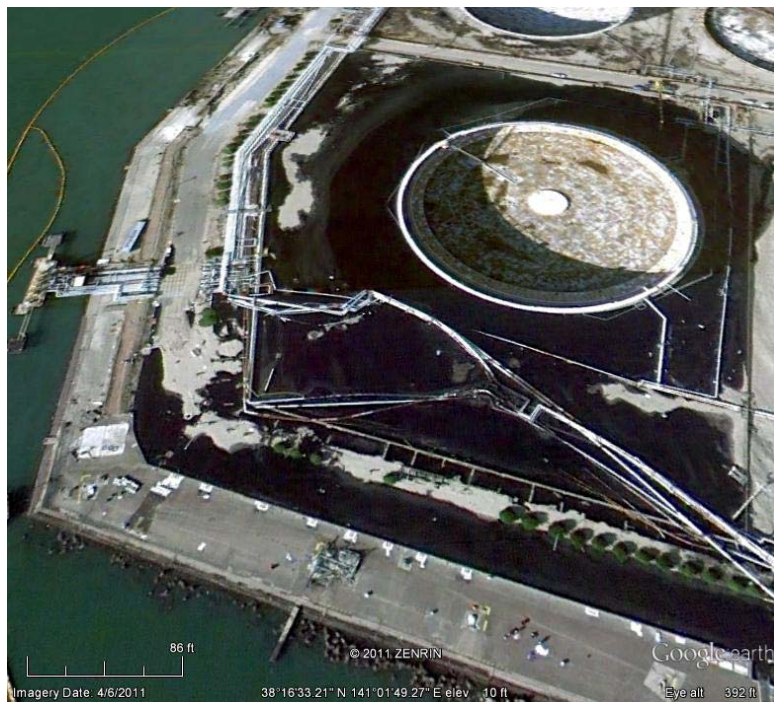
Fig. 2.12 Heavy oil release due to tsunami-triggered damage at the Sendai refinery (©2011 Google, ZENRIN)

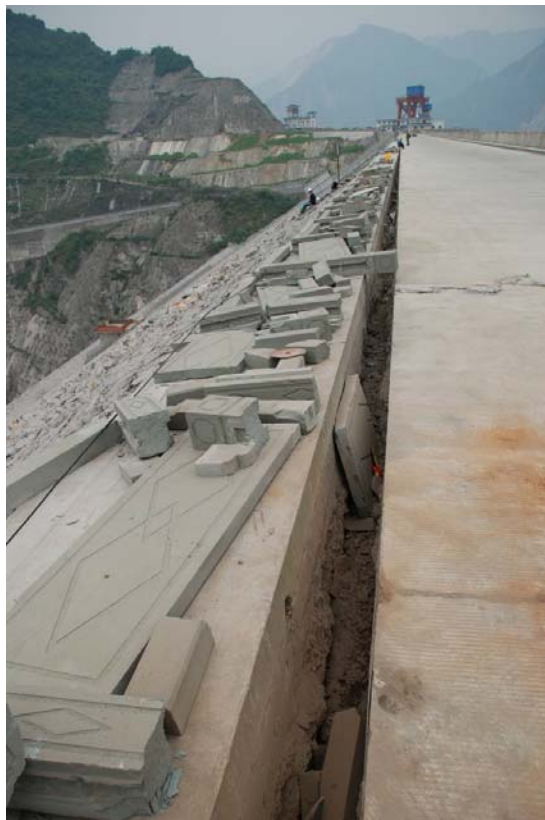
Fig. 3.1 Fracture at the Zipingpu dam's crown (taken from Lekkas, 2008)

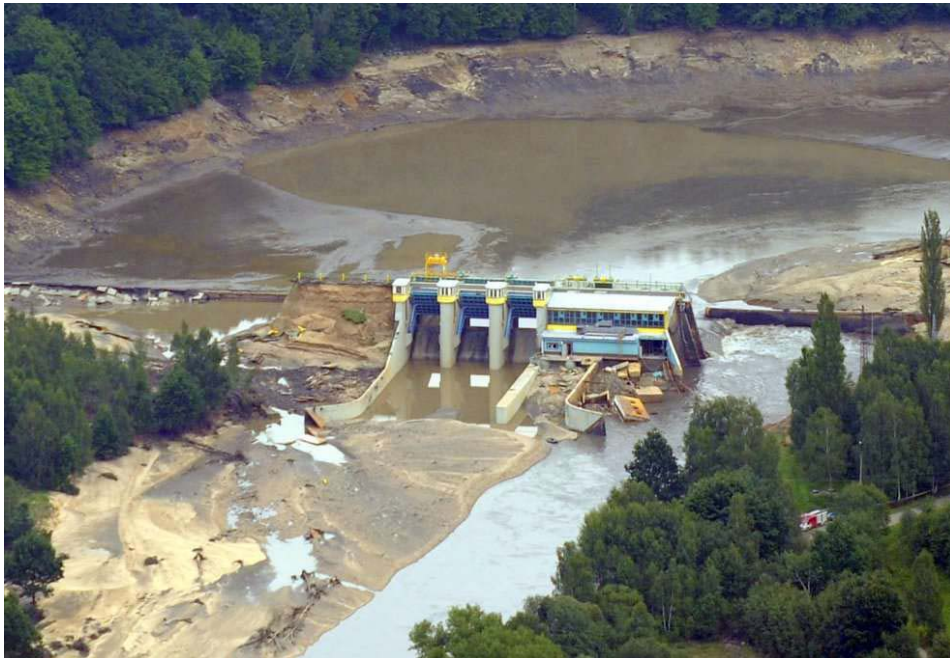
The embankment dam was completely destroyed by the flood.

Fig. 3.2 Failure of the Niedow dam in Poland due to flooding (taken from Fry et al., 2012)

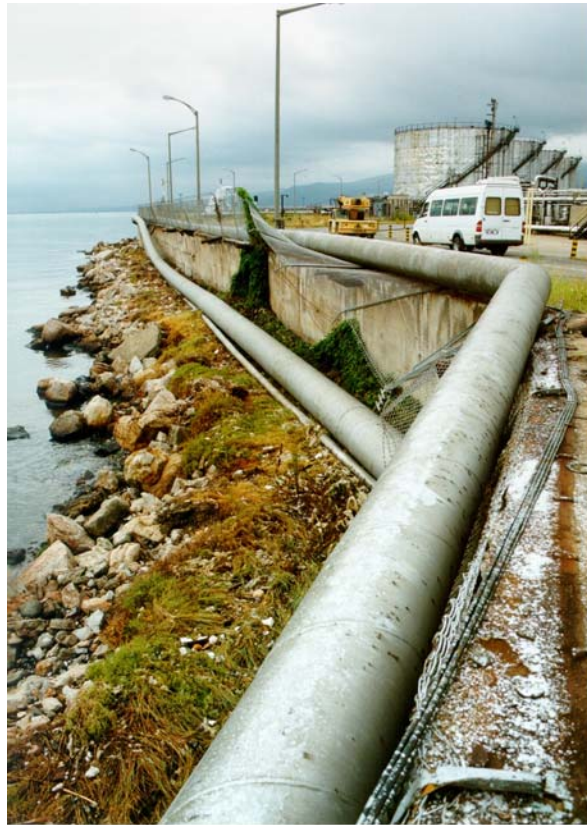
Fig. 4.1 The ground-supported unseated crude oil unloading pipeline fell from the supports at TUPRAS refinery due to inertial effects (Courtesy of TUPRAS (2000))

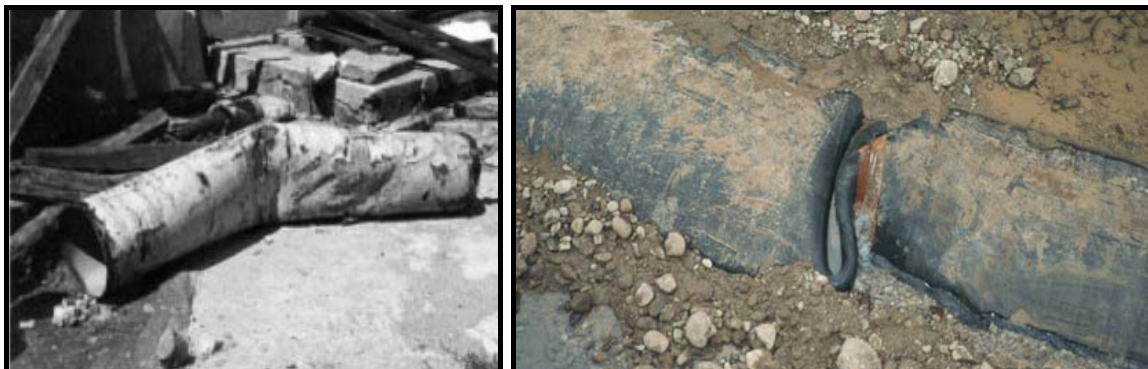
There was some damage to major continuous steel water transmission lines, especially where they crossed the fault zone or where severe permanent ground displacements occurred near Arifiye (Erdik and Uckan, 2013; Takada et al., 2001; EERI, 1999). Damage and failure mechanisms included wrinkling and buckling (Fig. 4.2).

Fig. 4.2 Failure (wrinkling) of a large diameter welded steel pipe crossing the ruptured fault in Arifiye (East of Izmit (left) (Takada et al., 2001) and buckled steel pipe connection (Bilham et al. 2003)

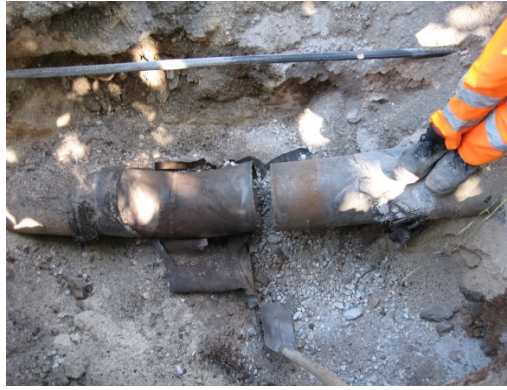
Fig. 5.1 Damage to gas pipes following the L`Aquila earthquake: gas welded joint of a LP steel pipe pulled apart in Paganica (Esposito et al., 2013)

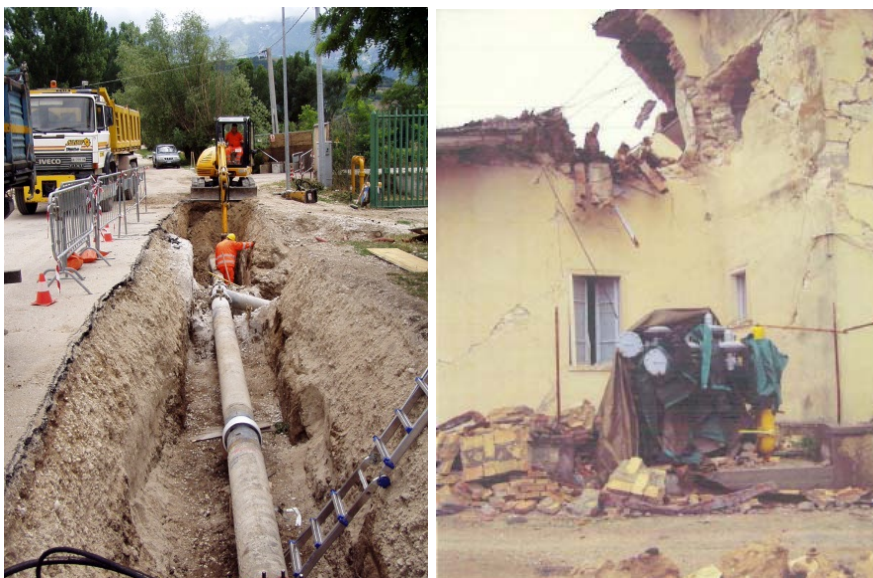
Fig. 5.3 Damage to stations: repairs to the input/output network of Onna M/R and inclusion of stop-system (left); RG housed in a masonry kiosk closed to building and damaged following the earthquake (right) (Photos courtesy of ENEL Rete Gas)

Post-earthquake activities also addressed the repair and upgrade (inclusion of safe-stop systems) of the input/output substation network of two M/R stations (Fig. 5.3a). The three M/R stations of the L'Aquila distribution system are cased in one-story reinforced concrete structures with steel roofs and no damage was observed to the buildings. The regulator and mechanical equipment for the M/R stations resulted undamaged. One of the principal causes of earthquake-induced damage to different types of RG stations was the collapse of rubble from adjacent buildings (Fig. 5.3b). As a consequence, some RGs in L'Aquila and Onna had to be replaced concurrently with the laying of new pipe.

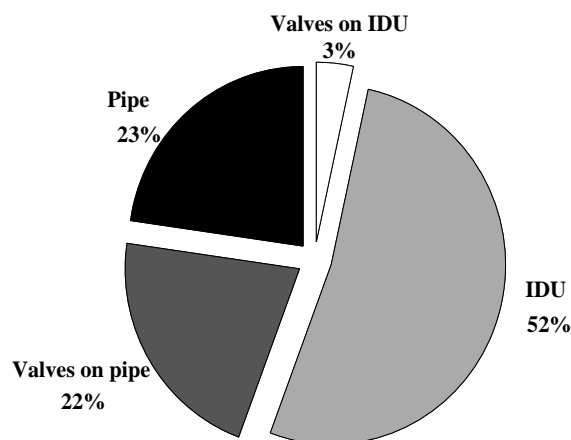
Fig. 5.4 groups the repair percentages for the four buried system components considered in this analysis (pipe, service laterals (IDU system), valves along pipes and valves along IDU systems). The data are relative to Zone 1, which corresponds to the area of the city of L'Aquila.

Fig. 5.4 Repair operations addressing damage to buried components for the portion of the gas network located in Zone 1: number of repairs for different buried components (Esposito et al., 2013)

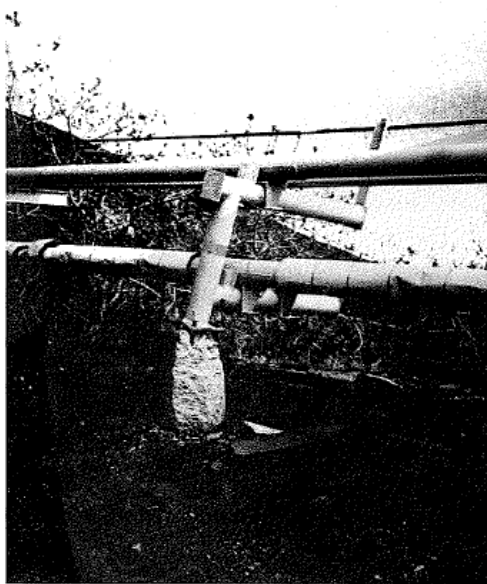
Fig. 5.6 Damaged support of aboveground gas line (Lau et al., 1995)

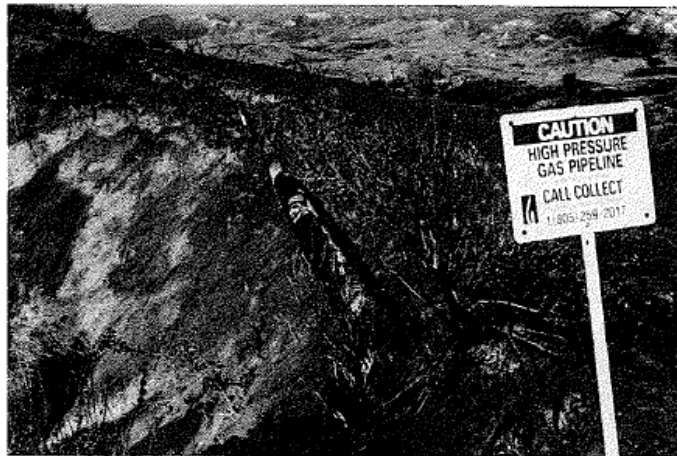
Fig. 5.7 Buried gas line exposed by landslide (Lau et al., 1995)

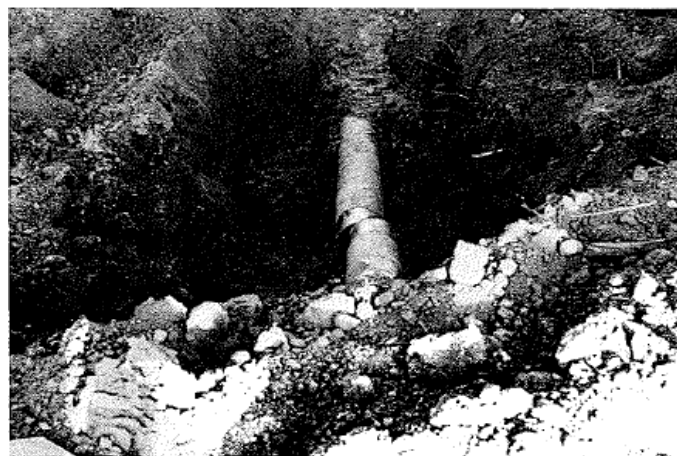
Fig. 5.8 Shear failure of gas line (Lau et al., 1995)

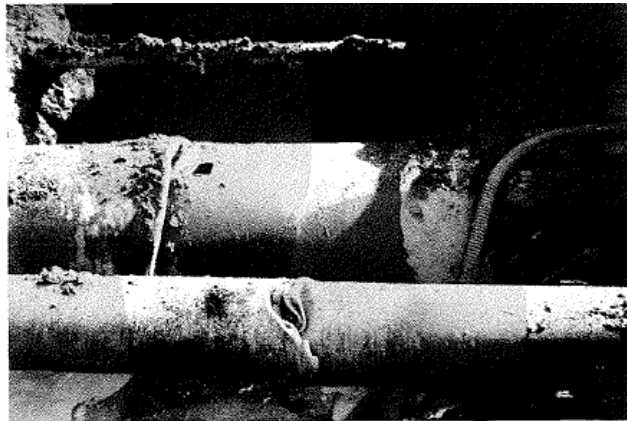
Figure 5.9 shows the failure in compression of a 55.9 cm (22 in) gas transmission line and an adjacent 106 cm (42 in) water line. Using the observed damage information it was estimated that the maximum earthquake-triggered compressive deformation of the surface soil at this location was about 30 cm (Lau et al., 1995).

Fig. 5.9 Compression failure of gas and water lines (Lau et al., 1995)

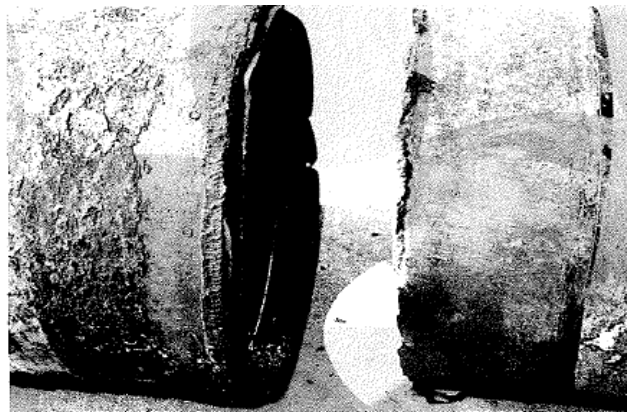
Lau et al. (1995) also report that the same gas line failed in tension at the weld at another nearby location (Fig. 5.10). The tensile deformation of the ground at this location was estimated to be of the same order of magnitude as the compressive deformation. A little farther south of the tension failure point, the gas line failed initially due to compression, followed by tensile fracture, and then finally by buckling (Fig. 5.11).

Fig. 5.10 Tension failure of gas line (Lau et al., 1995)

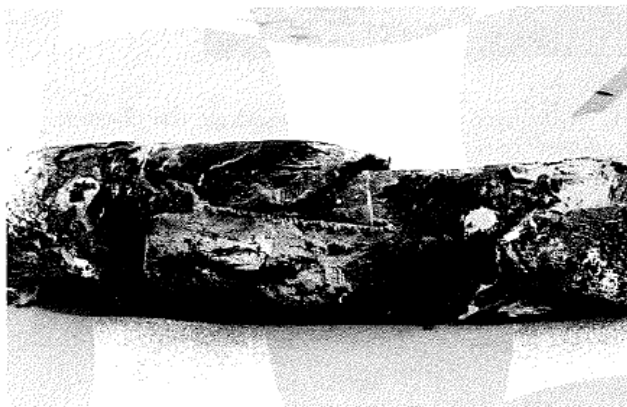
Fig. 5.11 Cycled compression, tension and buckling failure of gas line (Lau et al., 1995)

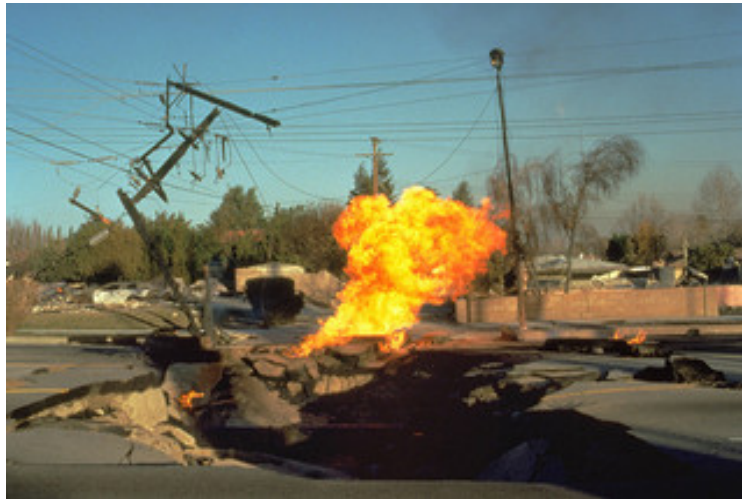
This site was located approximately 10 km north-east of the epicentre. A peak horizontal ground acceleration of 0.62g was recorded at a nearby location. The damage was evidently caused by the large ground displacement which occurred during the intense ground shaking of the earthquake. The damage covered several city blocks.

Fig. 5.12 Burning of leaked gas from ruptured gas line

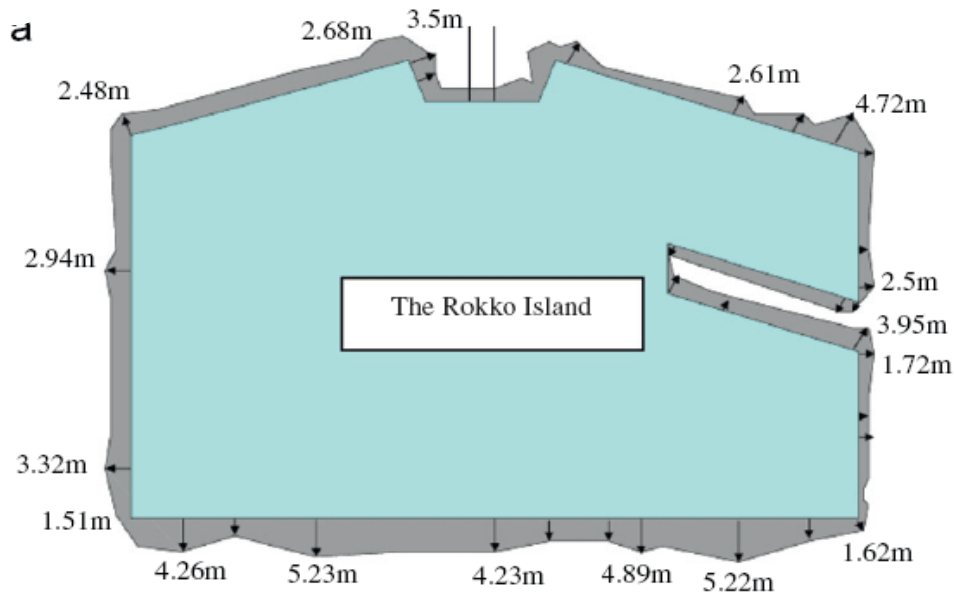
Fig. 6.1 Field observation of RHD for damaged quay walls at the Rokko Island in Kobe port (Inatomi et al., 1997)

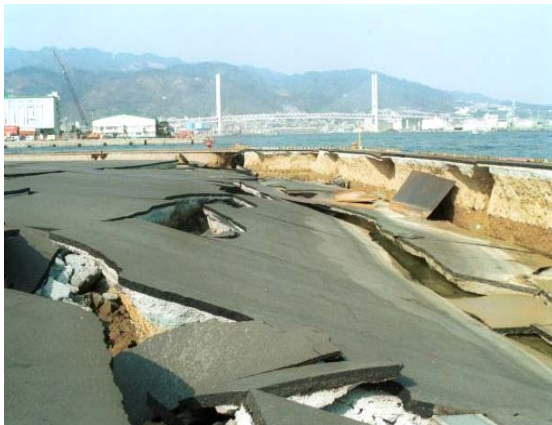
Fig. 6.2 Extremely extensive damage to apron pavements

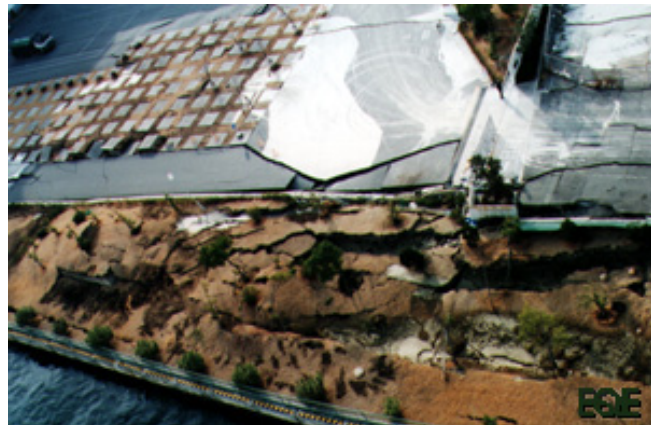
Fig. 6.3 Lateral spreading, liquefaction and settlement along the shore of the Port of Kobe

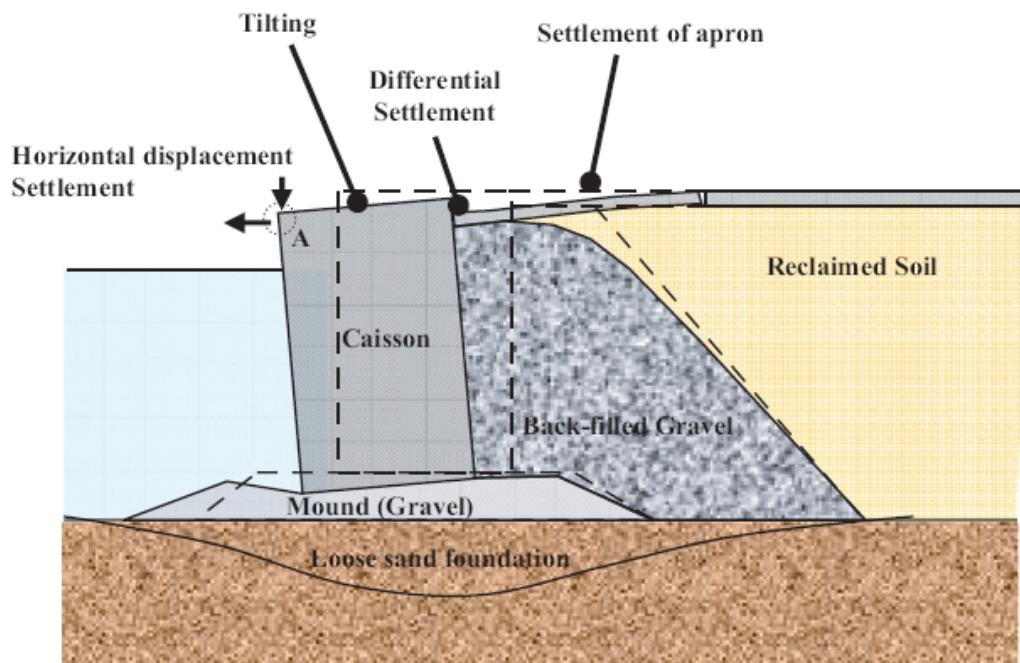
Figure 6.5 shows a schematic of the various damage modes of a typical caisson-type quay wall during the earthquake (Na et al. 2008).

Fig. 6.5 Typical damage modes for gravity type quay walls and parameters for damage criteria (Na et al., 2008)

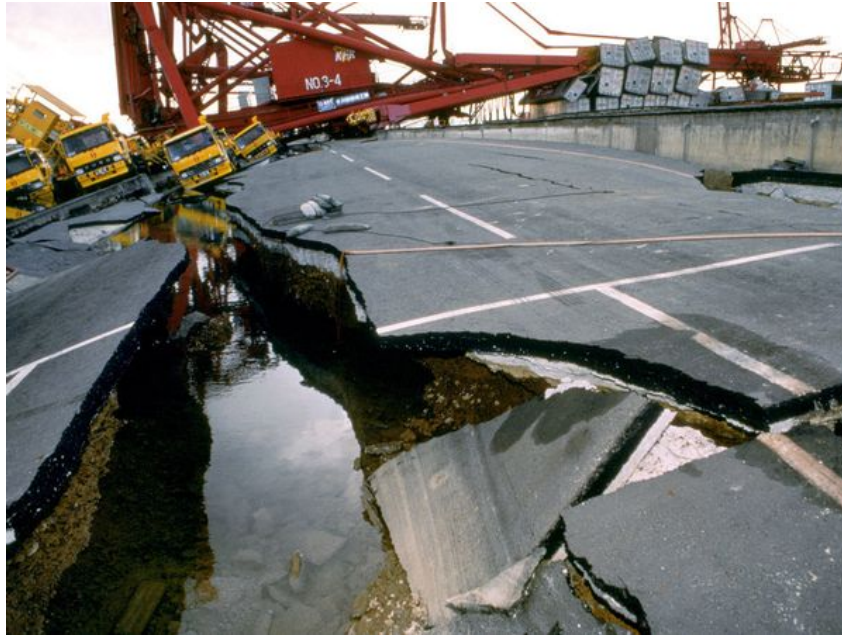
Fig. 6.6 Damage to a quay-wall at the port of Kobe (Nozu et al., 2004)

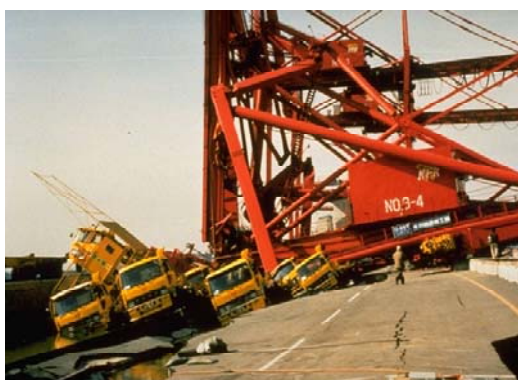
Fig. 6.9 Crane damage due to deformation of foundation soil

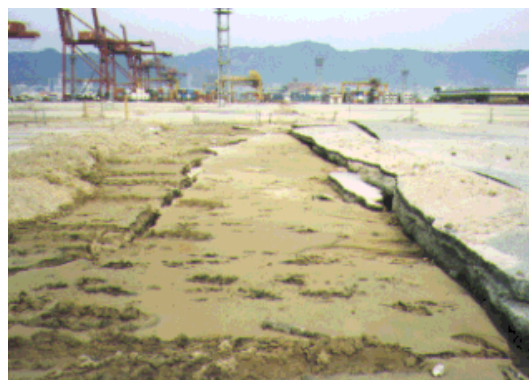
Fig. 6.10 Sand emersion near container cranes (Port Island)

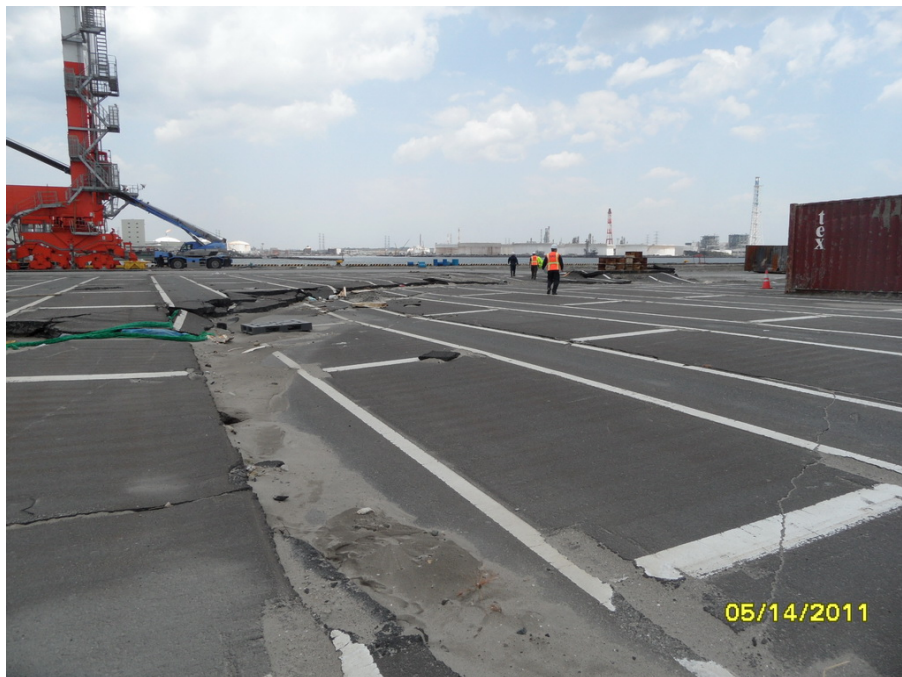
Fig. 6.15 Lateral spreading in the backlands along the original shoreline (Percher, 2014)

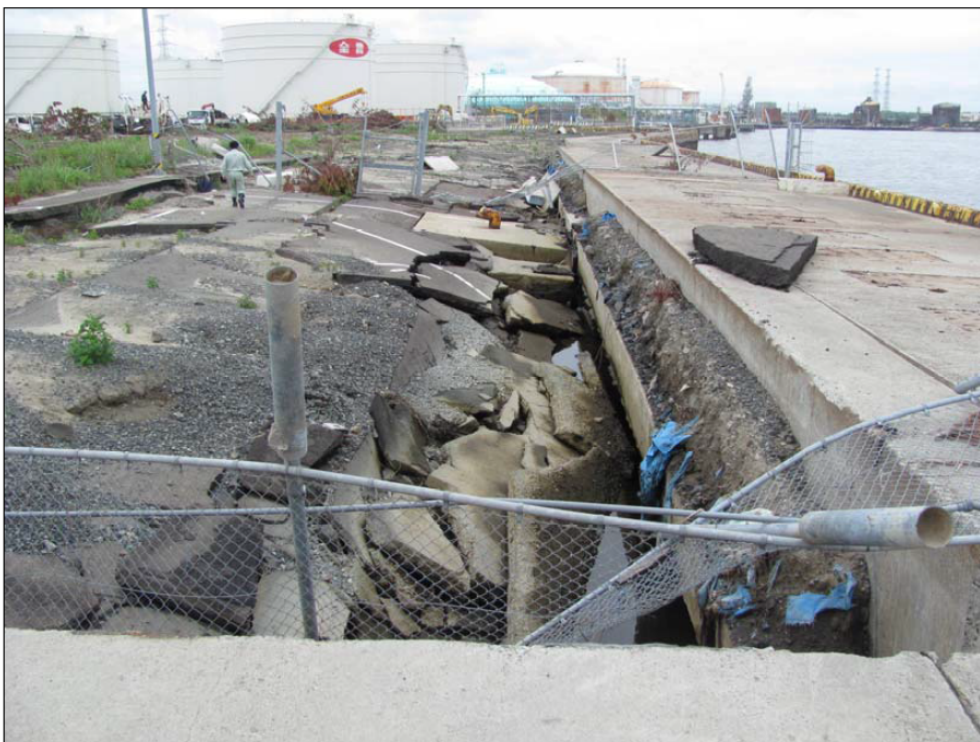
Fig. 6.18 Ground failure behind the quay wall at Sendai port (TCLEE, 2012)

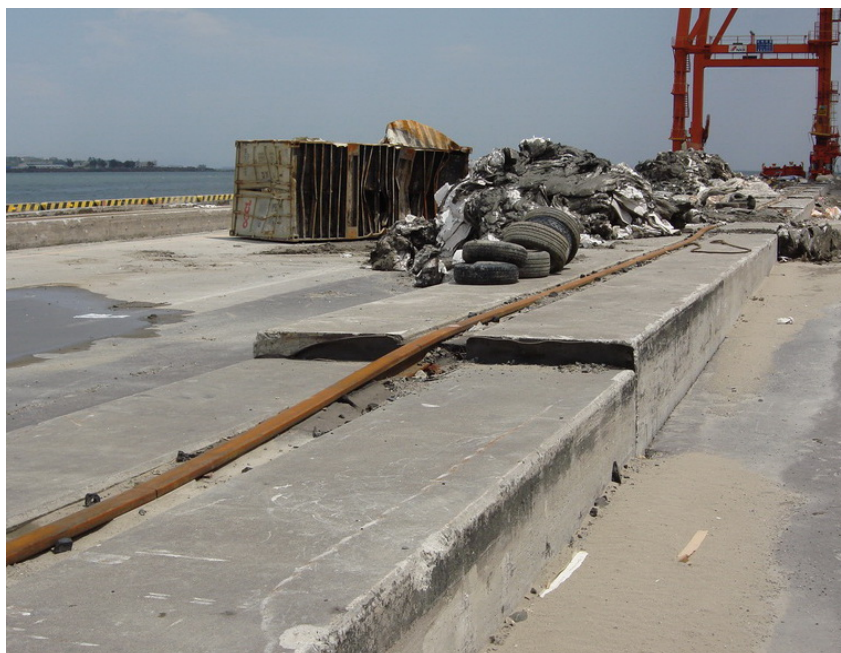
Fig. 6.19 Differential vertical movements of the crane rail girders and settlement of fill surface (Percher, 2014)

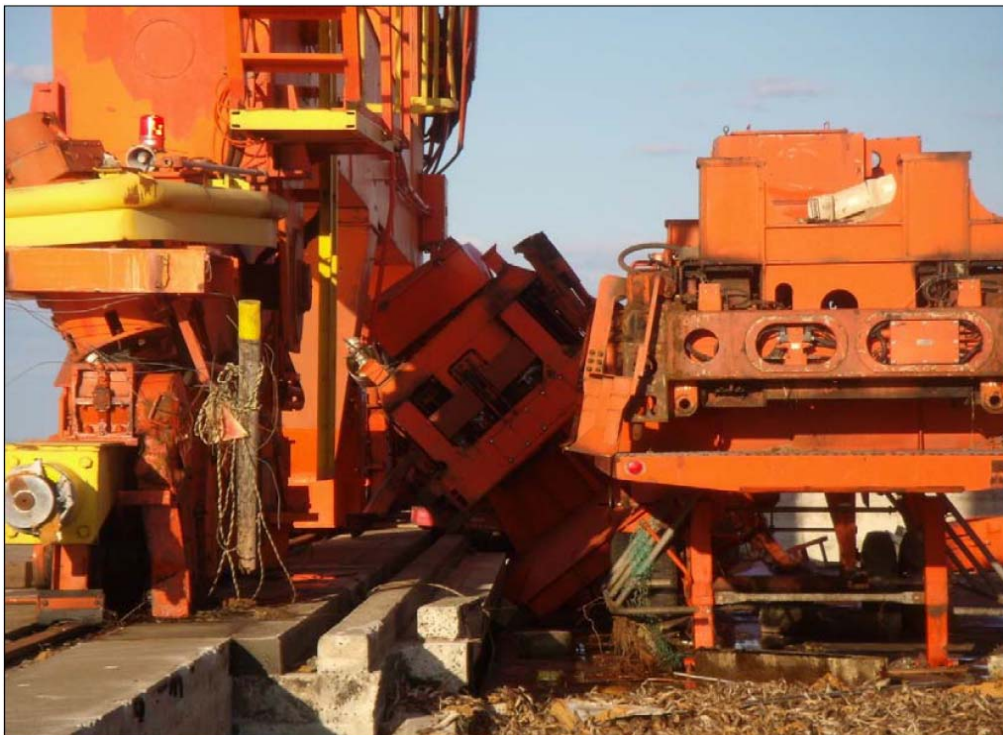
Fig. 6.21 Crane damage at Sendai Port (TCLEE, 2012)

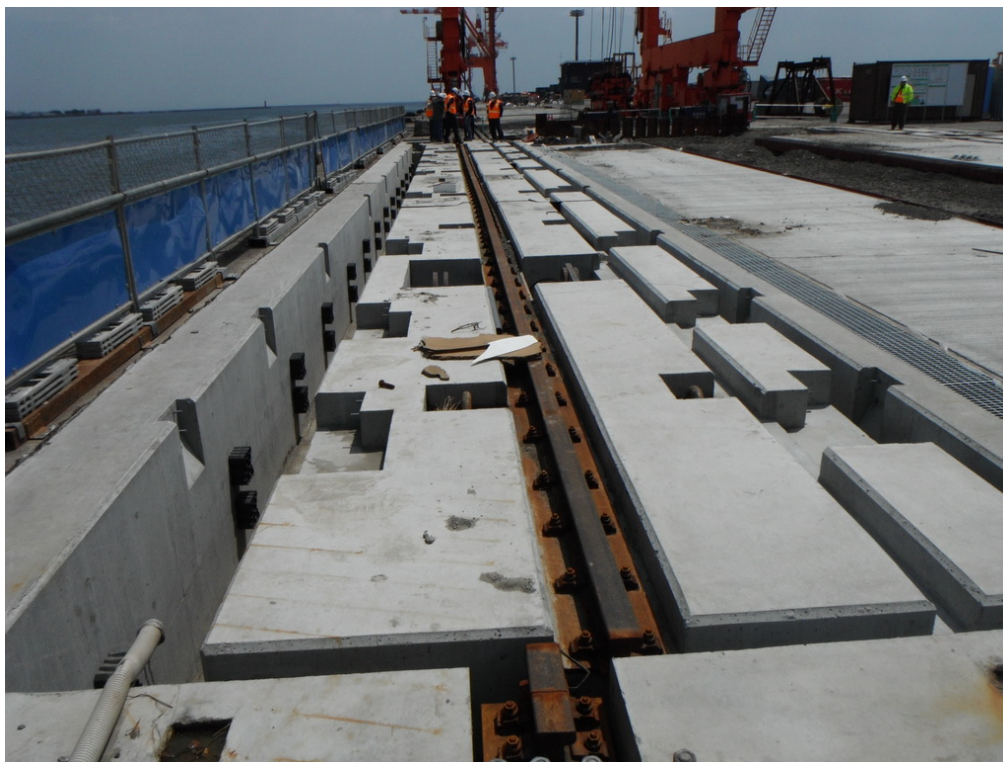
Fig. 6.22 Movement of waterside base isolated crane rails (Percher, 2014)

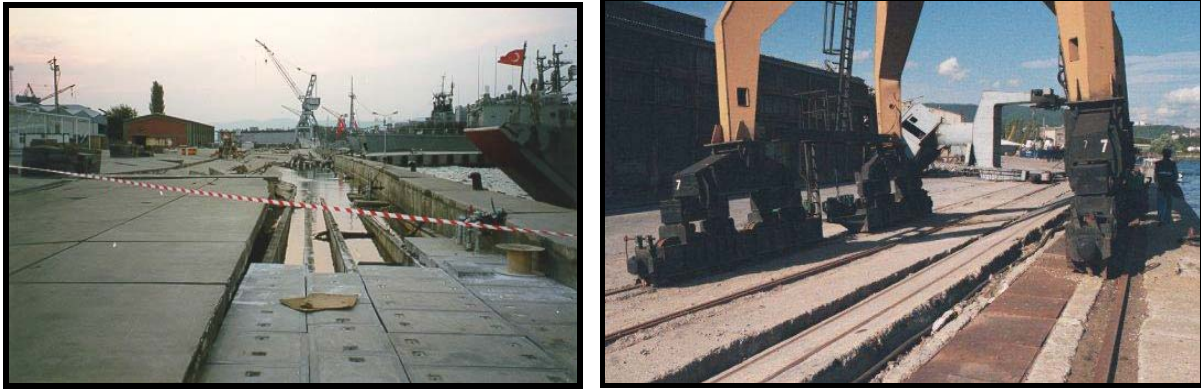
Fig. 6.25 Collapse of ground slabs due to settlement at the Navy port in Gölcük (left) and damage at Derince port (right)

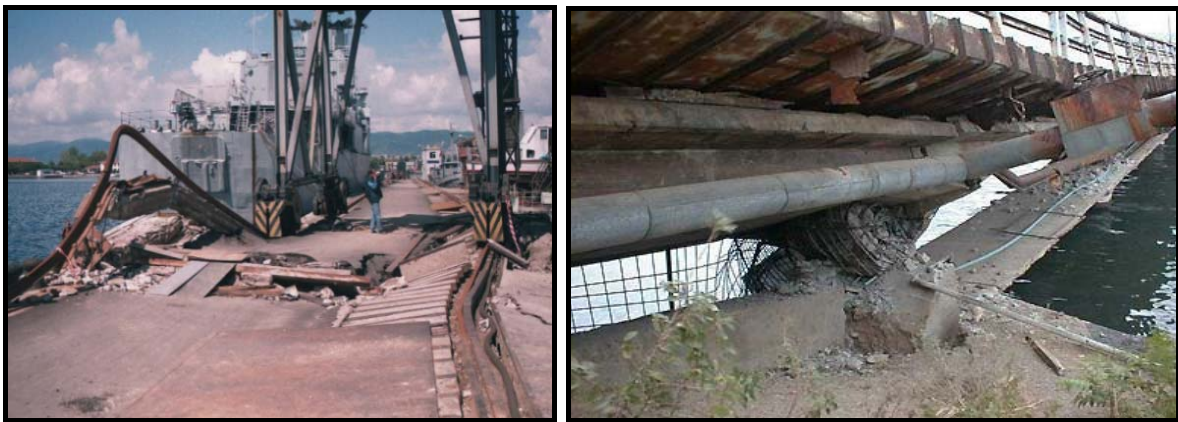
Fig. 6.26 Damage at the navy port in Gölcük (left) and failed column at SEKA port (right)

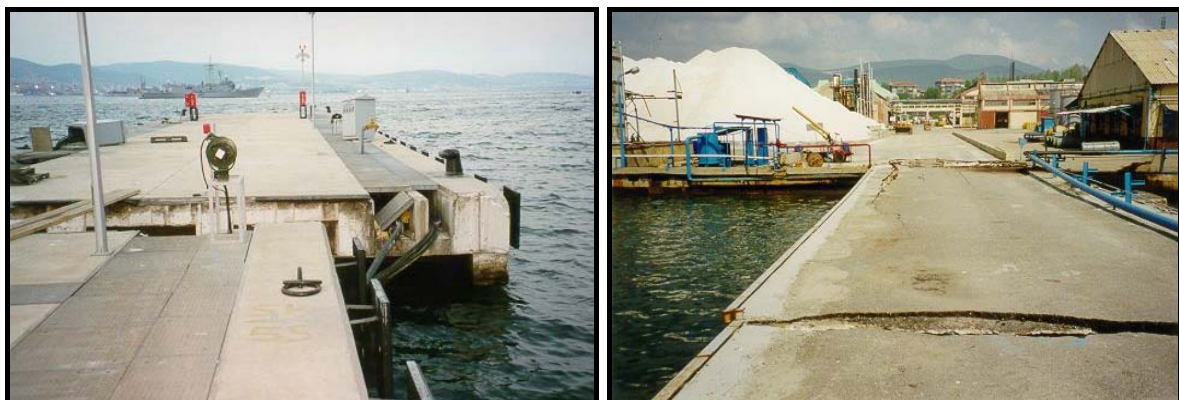
Fig. 6.27 A displaced steel piped jetty in Izmit (left) and a damaged jetty at Gölcük Naval Base (Bilham et al., 2003)

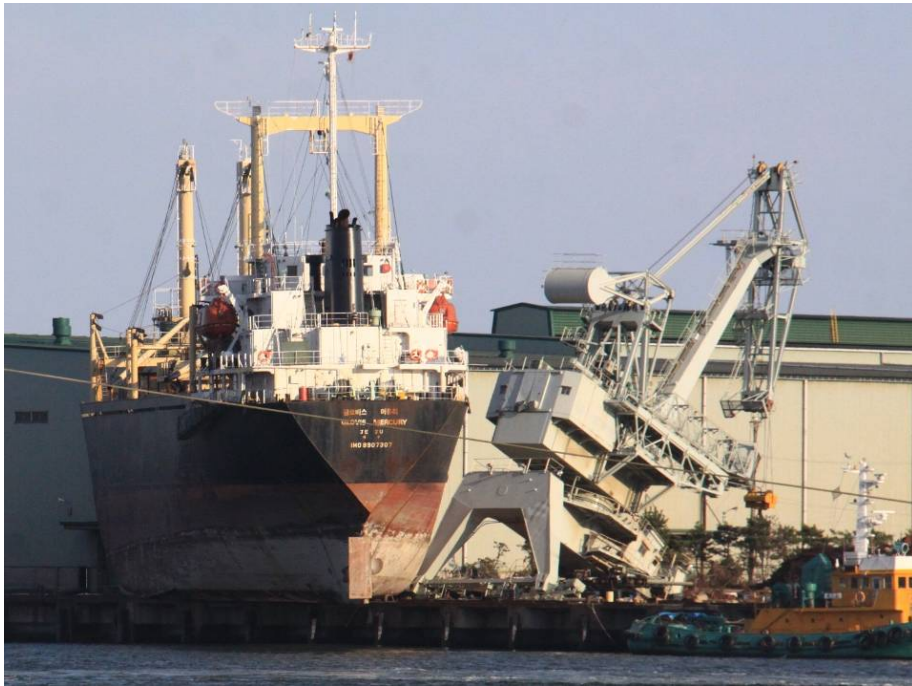
Fig. 6.29 Container ship swept ashore by tsunami at Sendai Port and damage on crane (TCLEE, 2012)

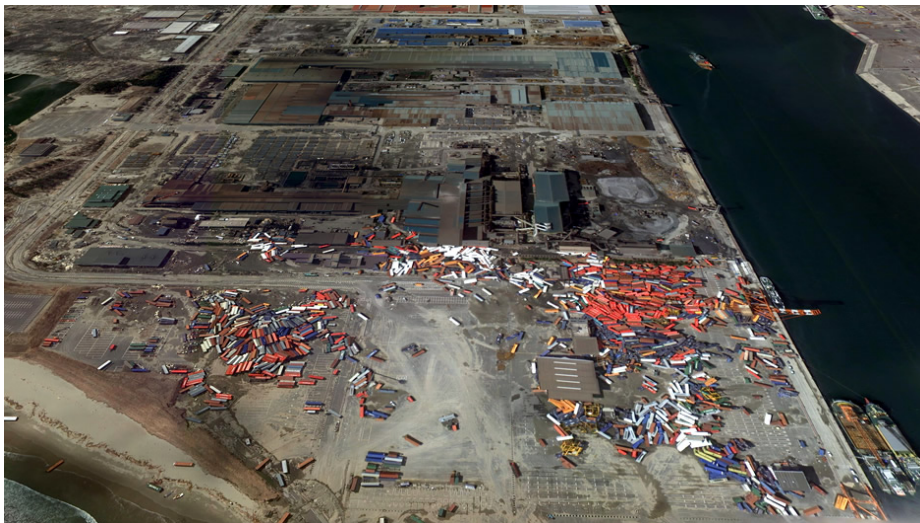
Fig. 6.30 Scattered containers Sendai Port after the tsunami (Tomita and Yoem, 2012)
