Project Title: **Harmonized approach to stress tests for critical infrastructures against natural hazards**

Acronym: **STREST**

Deliverable Title: **Report on lessons learned from recent catastrophic events**

Work Package: WP2 – State-of-the-art and lessons learned

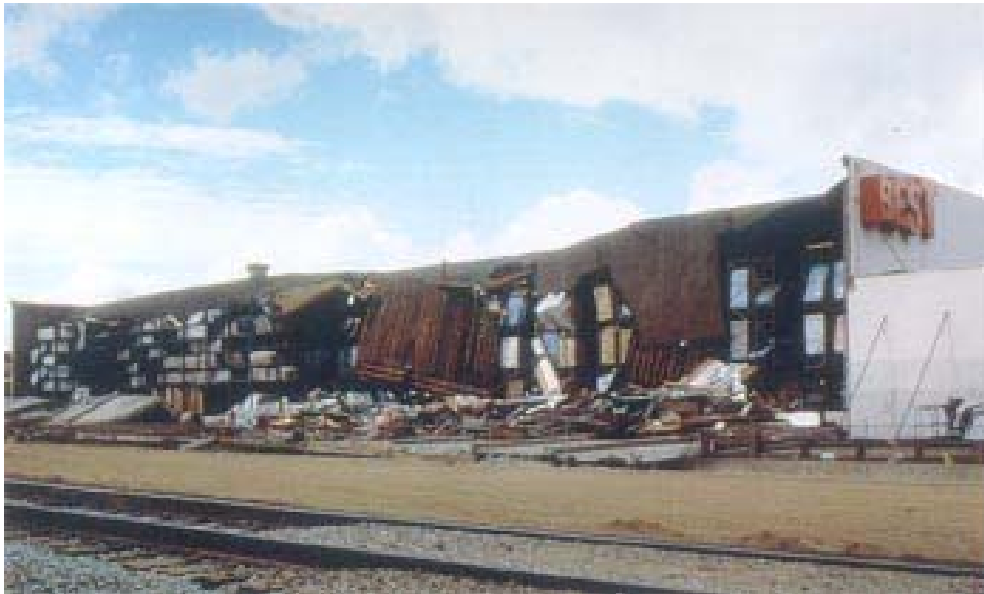
Fig. 7.1 Collapse of roof and wall elements of an old tilt-up building (Photo by G. Sakkestad²)

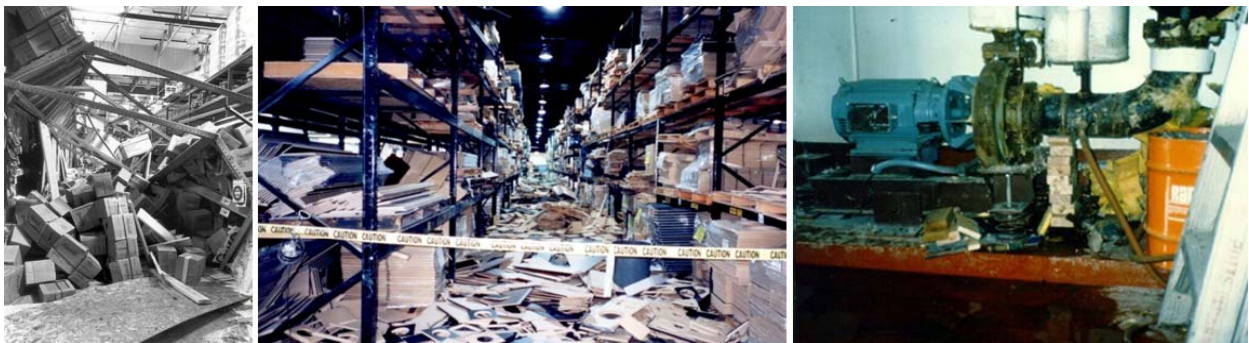
Fig. 7.2 Damage to industrial storage racks and equipment during Northridge Earthquake (Photos taken from FEMA 460 (2005) and FEMA E-74 (2011))

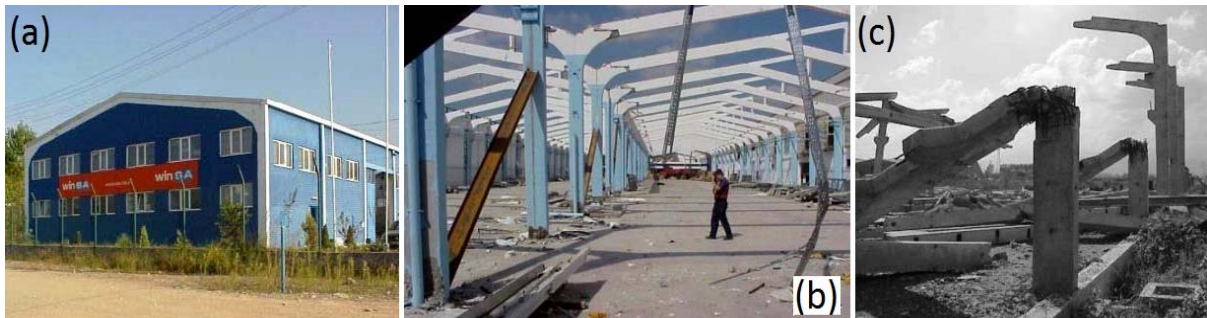
Fig. 7.3 Precast Industrial buildings sustained various degrees of structural damage (taken from Saatçioğlu et al., 2001)

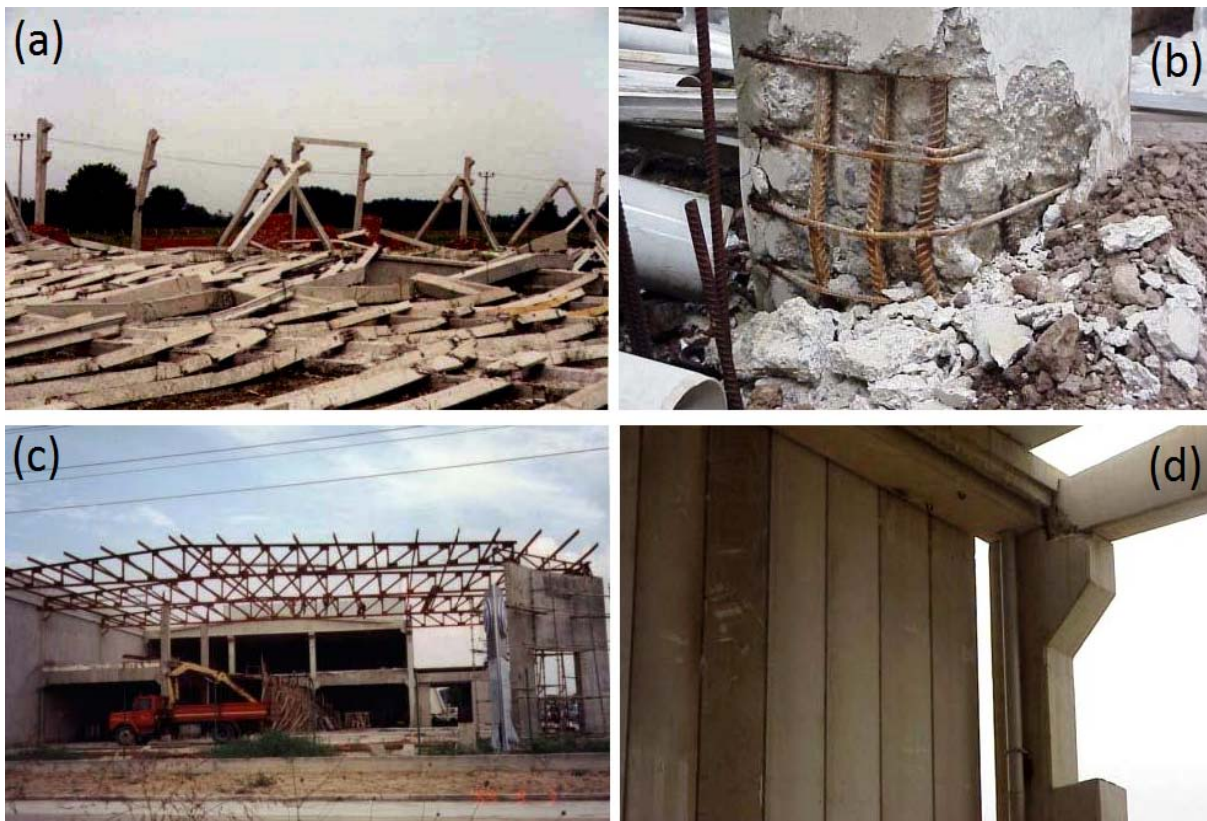
Fig. 7.4 Precast structures in the same industrial zone under different construction stages and corresponding damage levels (taken from Saatçioğlu et al. (2001))

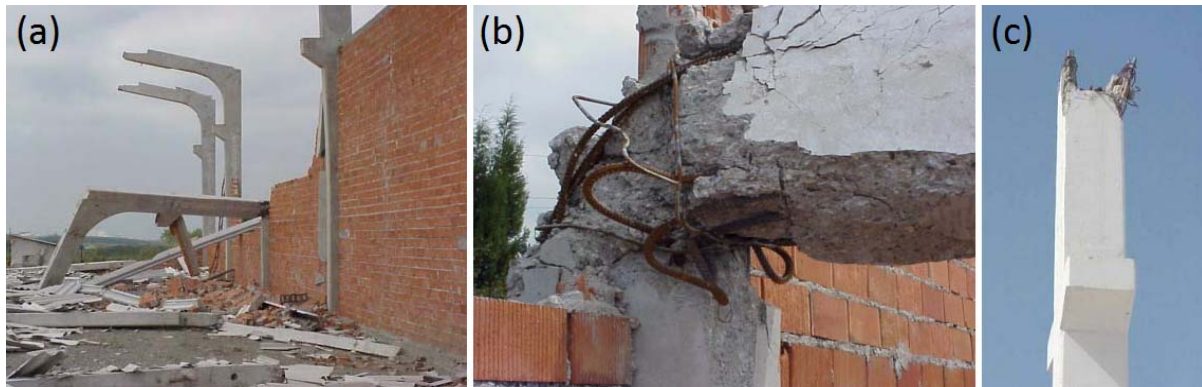
Fig. 7.5 Observed damage to precast industrial buildings (taken from Saatçioğlu et al., 2001)

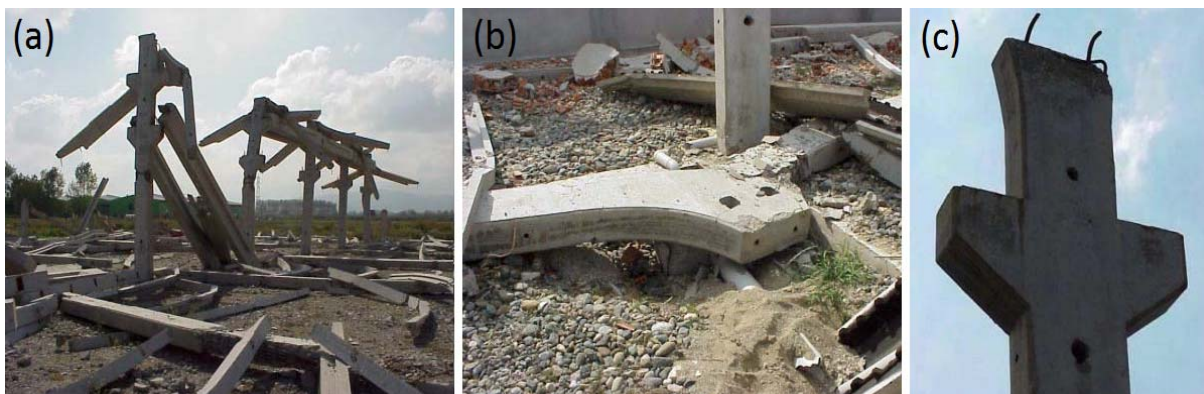
Fig. 7.6 Double cantilever to column connection failures (taken from Saatçioğlu et al., 2001)

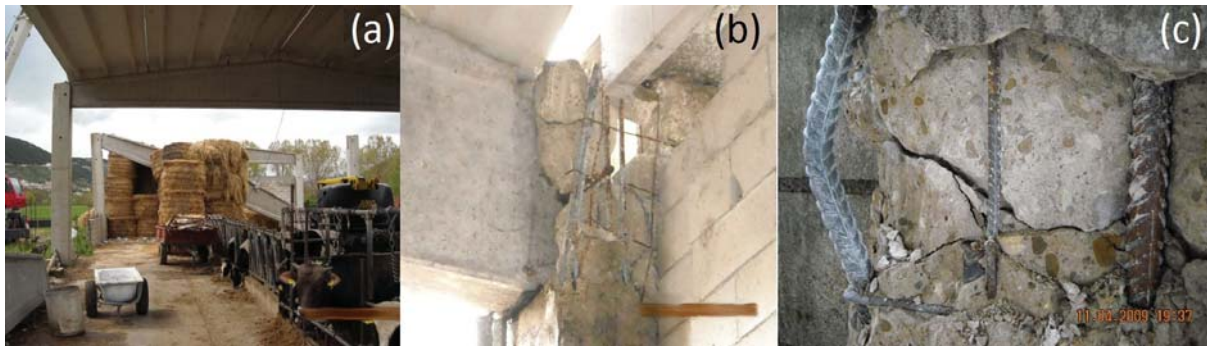
Fig. 7.7 Damage to structural elements observed by Toniolo and Colombo (2012)

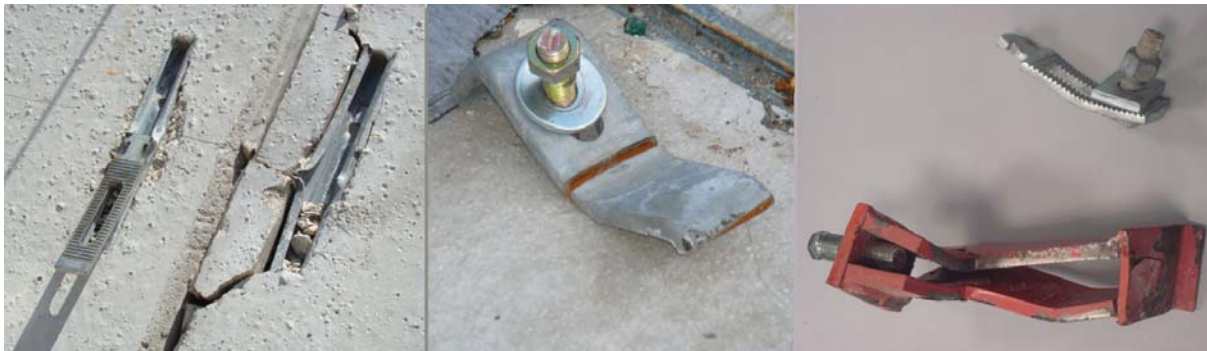
Fig. 7.8 Damage to connections and fastenings (Toniolo and Colombo, 2012)

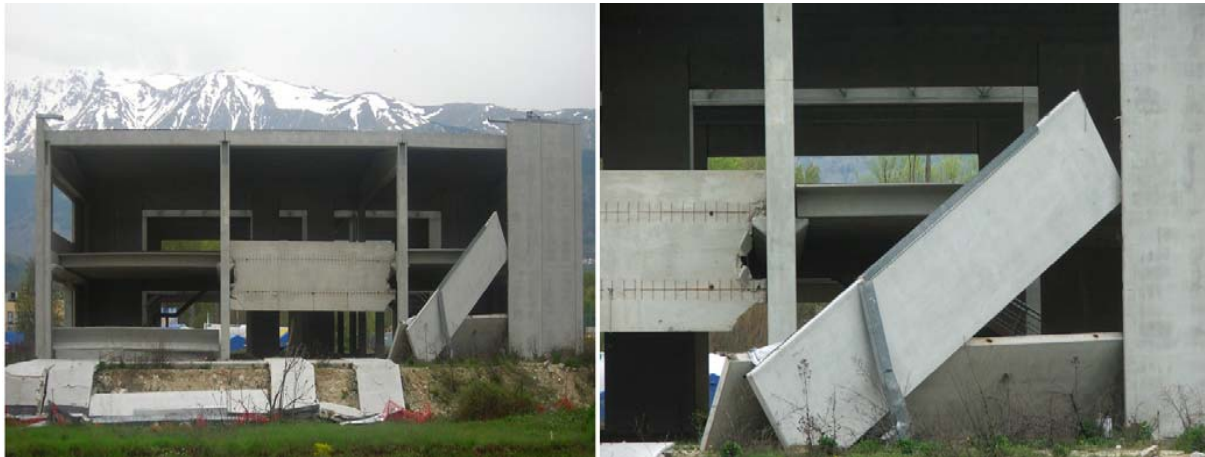
Fig. 7.9 Collapse of precast wall panels (Di Sarno et al., 2011)

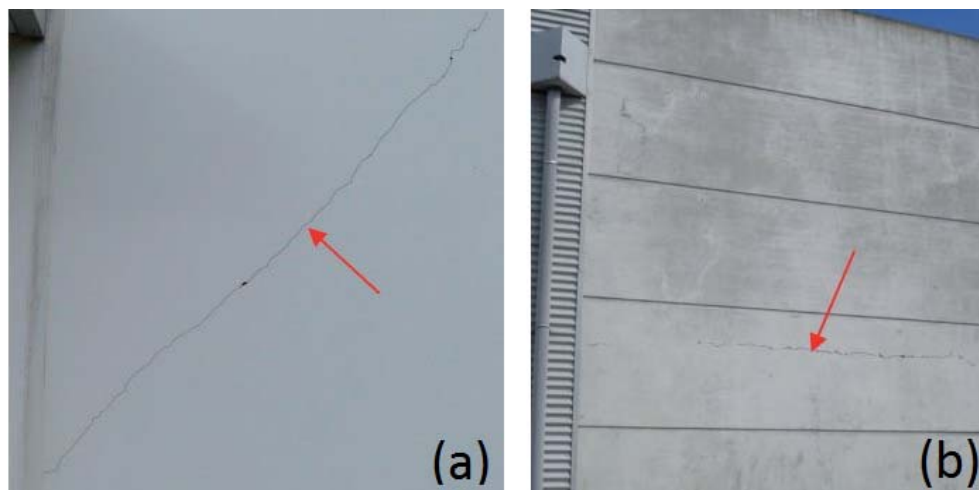
Fig. 7.10 Minor cracking in concrete panels (taken from Henry and Ingham (2011))

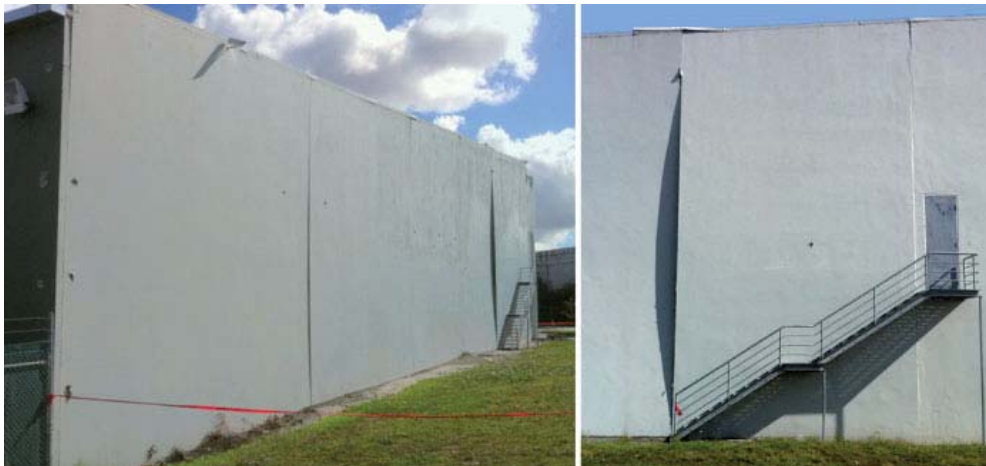
Fig. 7.11 Out-of-plane buckling of concrete wall panels (taken from Henry and Ingham (2011))

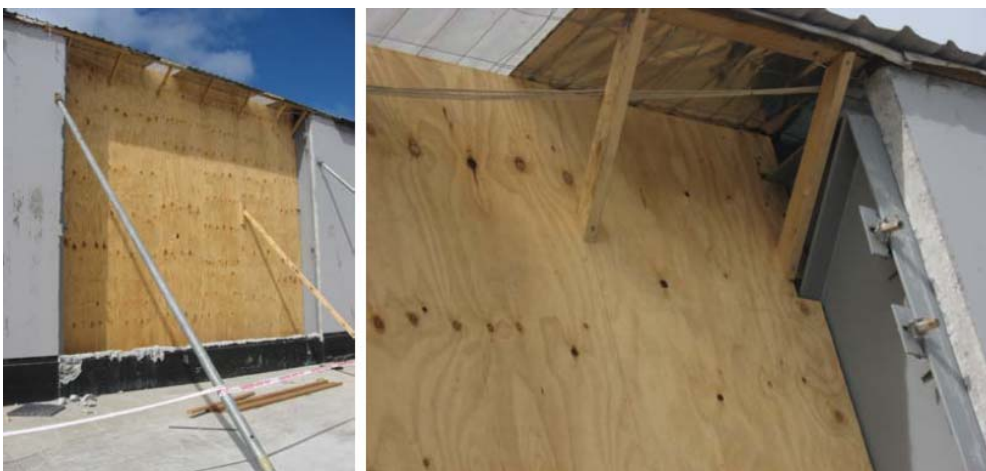
Fig. 7.12 Panel collapse due to steel frame connection failure (taken from Marshall and Gould (2012))

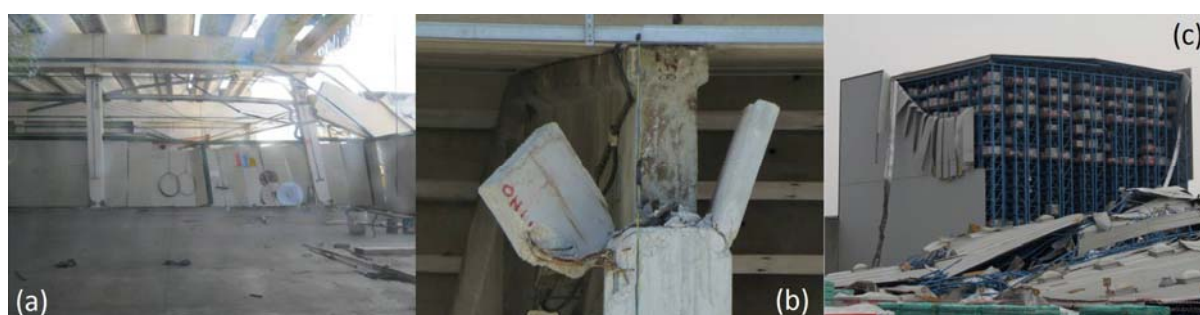
Fig. 7.13 Observed damage to industrial buildings (taken from Liberatore et al. (2013))

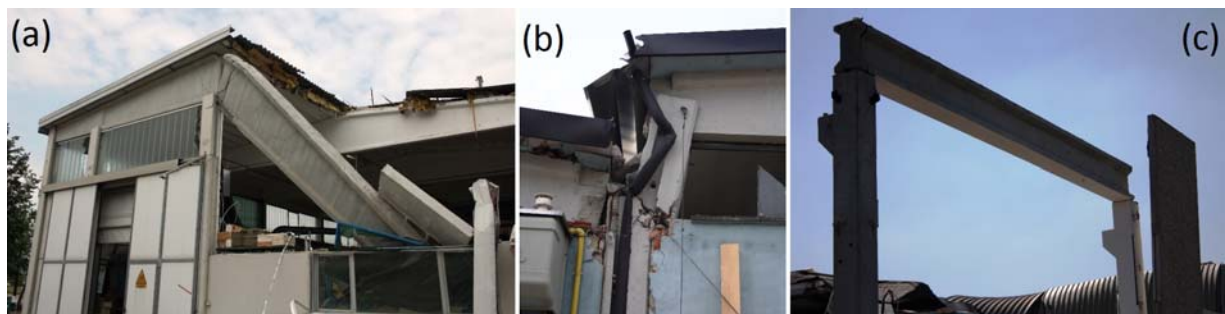
Fig. 7.14 Observed damage to beam-column connections (Source: Roberto Nascimbene, Eucentre)

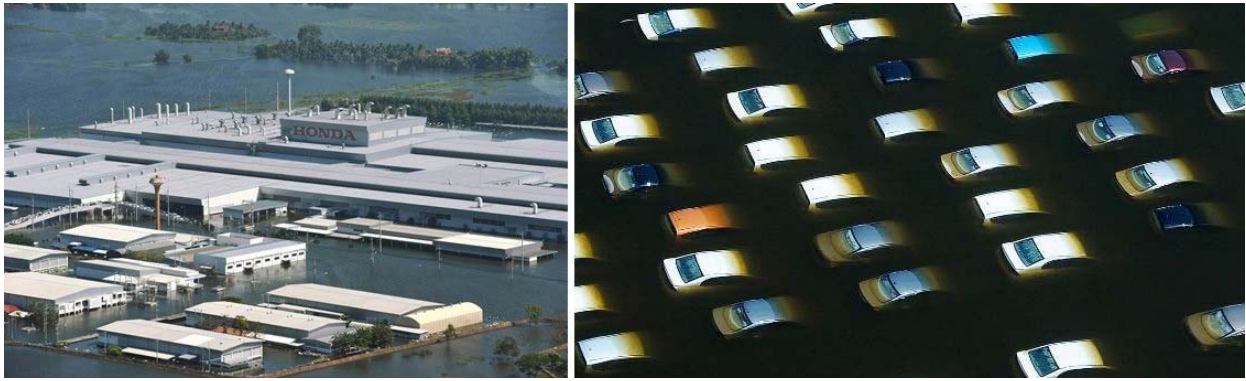
Fig. 7.17 Inundated automotive factory⁴ and submerged cars⁵ in Ayutthaya Province
