Project Title: **Harmonized approach to stress tests for critical infrastructures against natural hazards**

Acronym: **STREST**

Deliverable Title: **Report on lessons learned from recent catastrophic events**

Work Package: WP2 – State-of-the-art and lessons learned

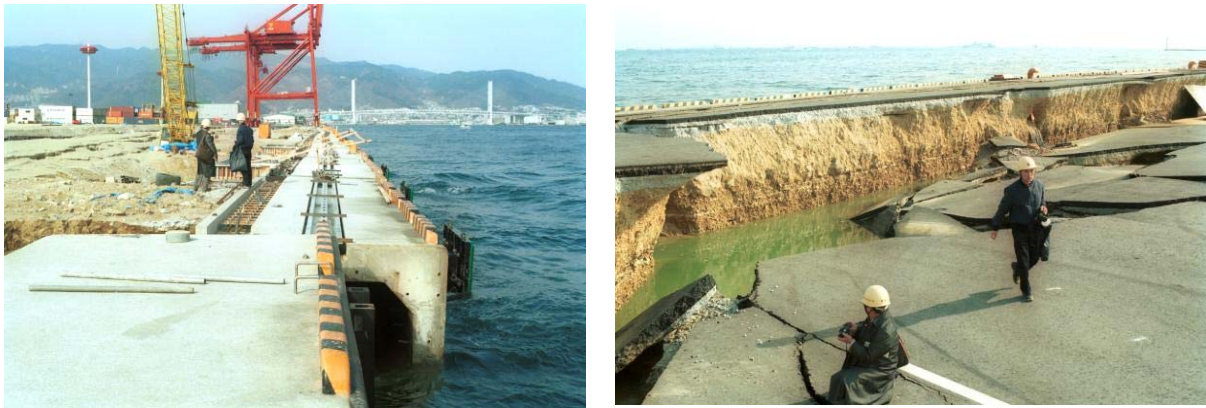
During the earthquake, significant tilting or rotation of walls in addition to horizontal deformations were observed, reflecting cyclic bearing capacity failures of wall foundations during earthquake loading (Figs. 6.2 and 6.3). Concrete caisson quay walls suffered substantial outward displacement and rotation (Fig. 6.4). The caissons did not overturn (Hamada and Wakamatsu, 1996; Inagaki et al., 1996; Kamon et al., 1996) which renders their overall performance better than that of anchored sheet-pile walls which in earlier earthquakes, that were much less devastating than the Kobe

Fig. 6.4 Seaward displacement and tilting of quay-walls

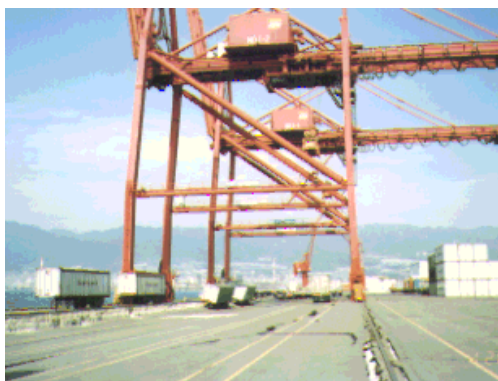
The causes of crane damage in Kobe Port are attributed to the lateral deformation of the caissons that carried the seafront rails of the cranes and the rocking vibration of the cranes, which resulted in excessive section forces on the legs and local buckling (Tanaka and Inatomi, 1996). During the earthquake, container crane supports failed, also resulting in significant damage. In some cases the crane rails spread until plastic hinging developed in the portal frame (Soderberg et al., 2009). One crane collapsed due to excessive spreading.

Fig. 6.7 Seaward lateral movement of rail foundation and differential settlement of rails (Rokko Island)

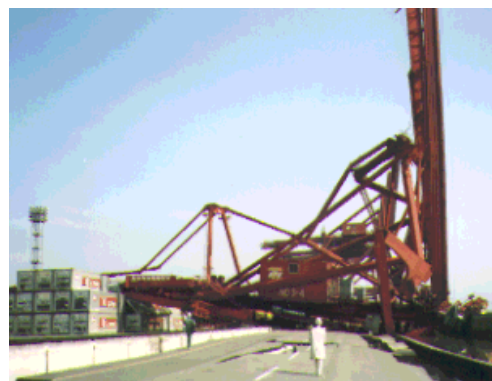
With respect to cargo handling equipment out of a total of 55 cranes, 22 were slightly damaged (Level II damage) by the Kobe earthquake and 30 cranes were seriously damaged (Level III damage). Characteristic failure modes of cranes during the earthquake are shown in Figs. 6.7 – 6.10. A classification of the damage is shown in Table 6.1 (Tanaka and Inatomi, 1996).

Fig. 6.8 Crane total collapse. Various damages to other cranes like plastic hinges and bending of their members (Rokko Island)

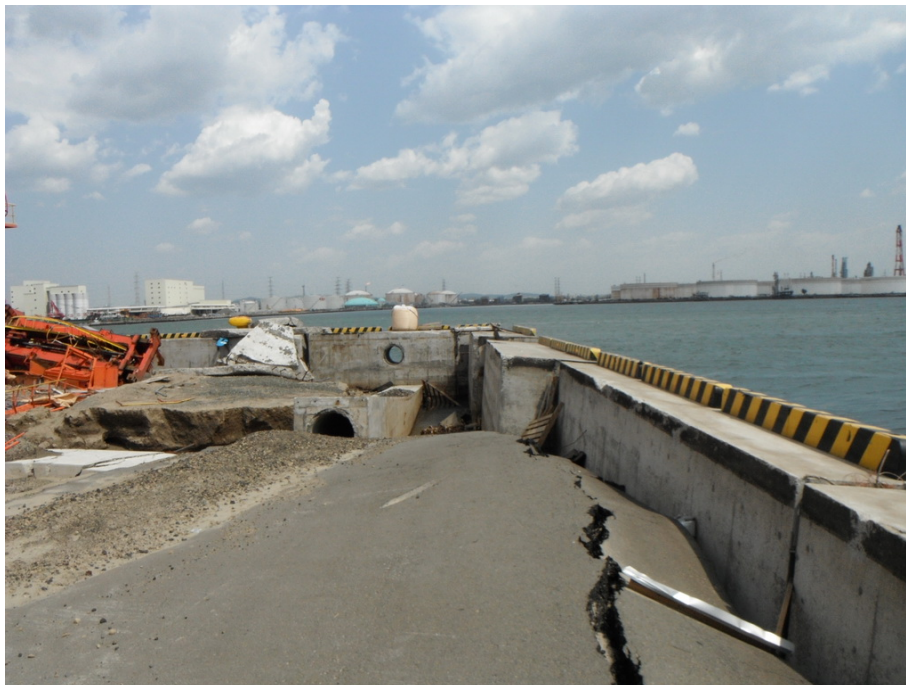
Fig. 6.16 Rotated wharf closure bulkhead at the east end of the Takasago wharf (Percher, 2014)

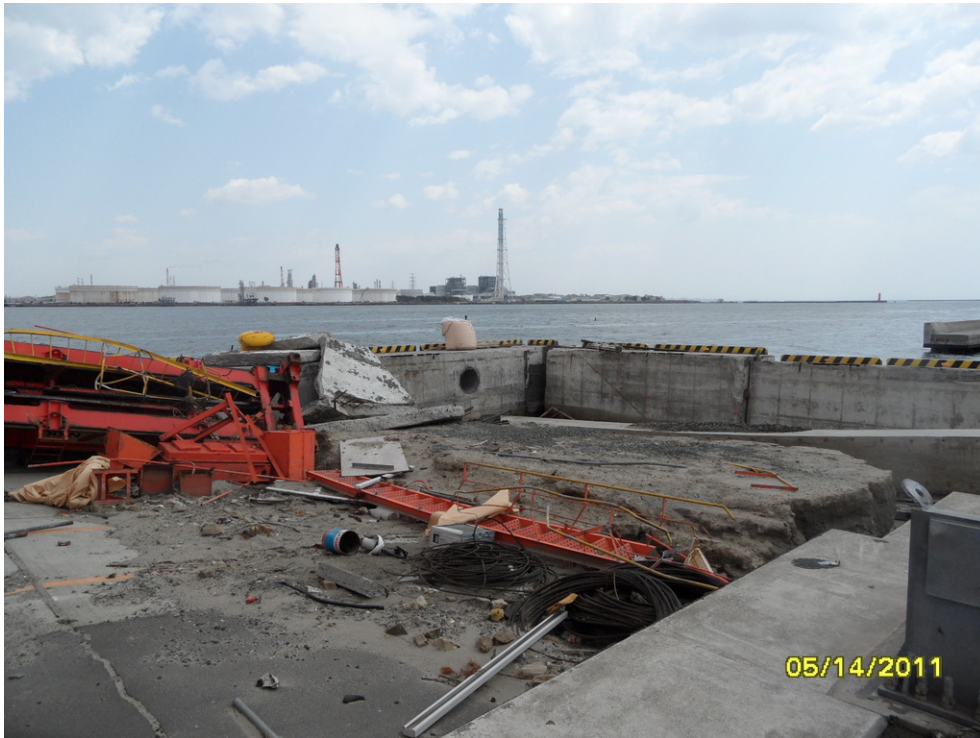
Fig. 6.17 Significant vertical settlement near the east end the Takasago wharf (Percher, 2014)

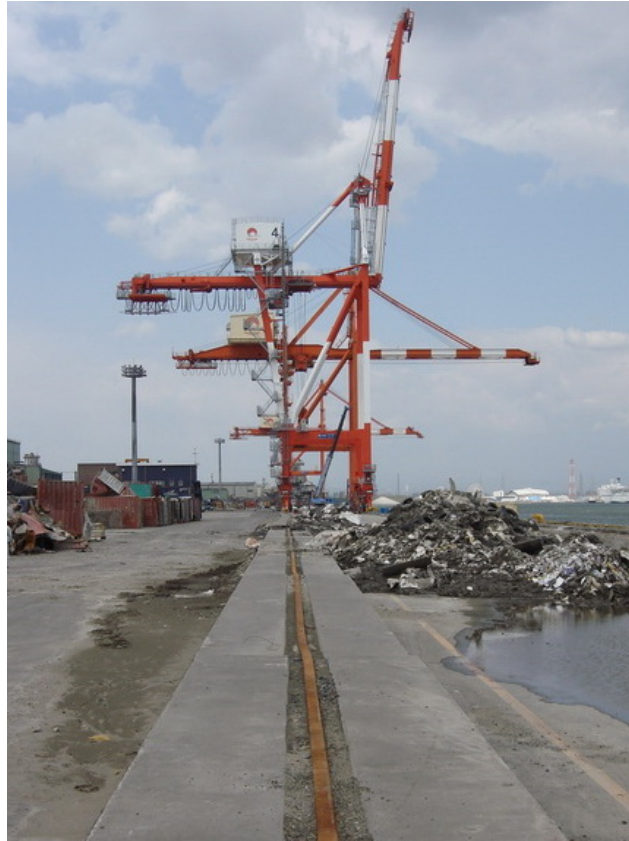
The cranes of Sendai Port performed well in general. The minor permanent deformations of the Takasago wharf resulted in differential horizontal movements between the construction joints of the crane rails, in response to the lateral spreading thereby, as shown in Fig. 6.20 (Percher, 2014).

Fig. 6.20 Landside crane rails at the eastern side of Takasago Wharf (Percher, 2014)

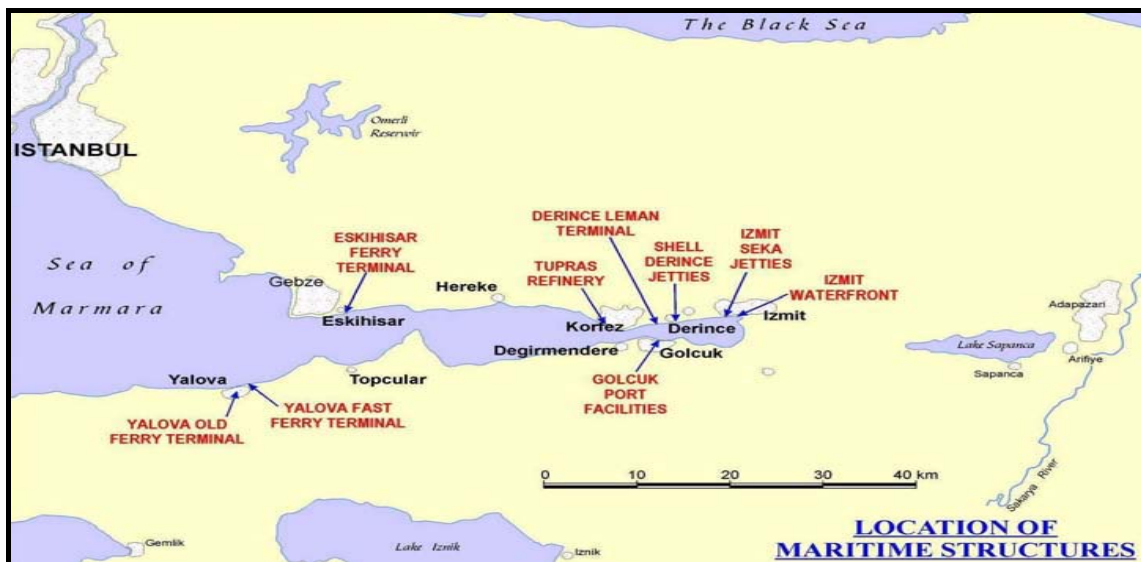
Most of the port facilities damaged by the Kocaeli earthquake are within 10 km of the fault rupture and lie in intensity zone IX. Marine structures in Izmit Bay were affected severely by the Kocaeli earthquake (Fig. 6.24). The structures on the southern shores of Izmit Bay are mainly on alluvial and marine deposits and those along the northern shores of the bay are on relatively stiff soil (Durukal and Erdik, 2008).

Fig. 6.24 Location of port structures around İzmit Bay

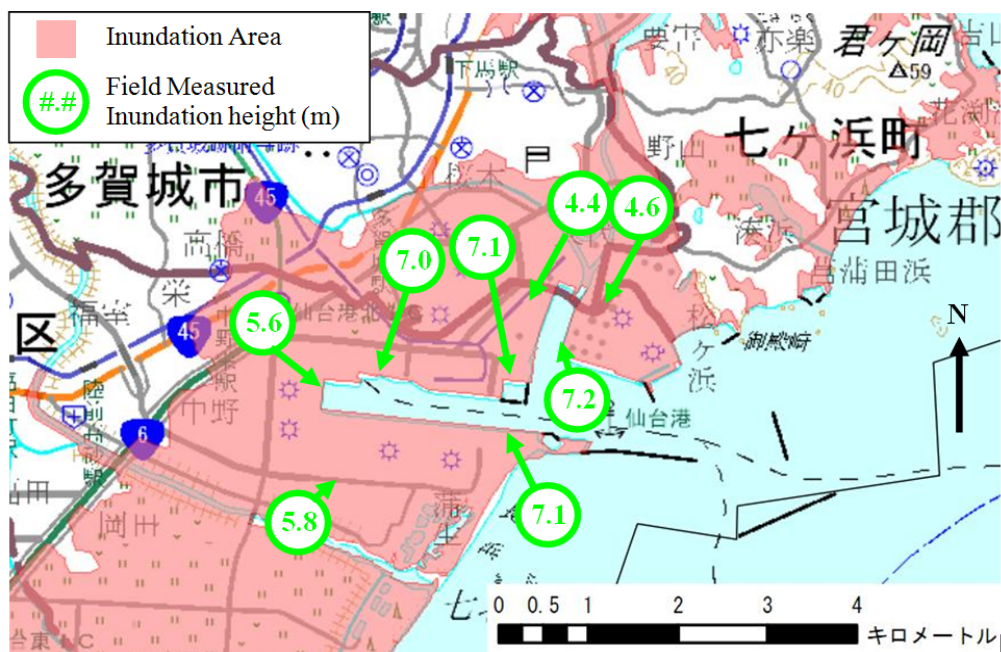
The tsunami triggered by the Great East Japan earthquake affected a wide swath of land and caused a large number of fatalities, injuries, and destruction of infrastructures. At Sendai Port, the inundation height varied between 4 and 7 m maximum, as shown in Fig. 6.28 (Percher, 2014).

Fig. 6.28 Inundation heights in Sendai Port (Percher, 2014)

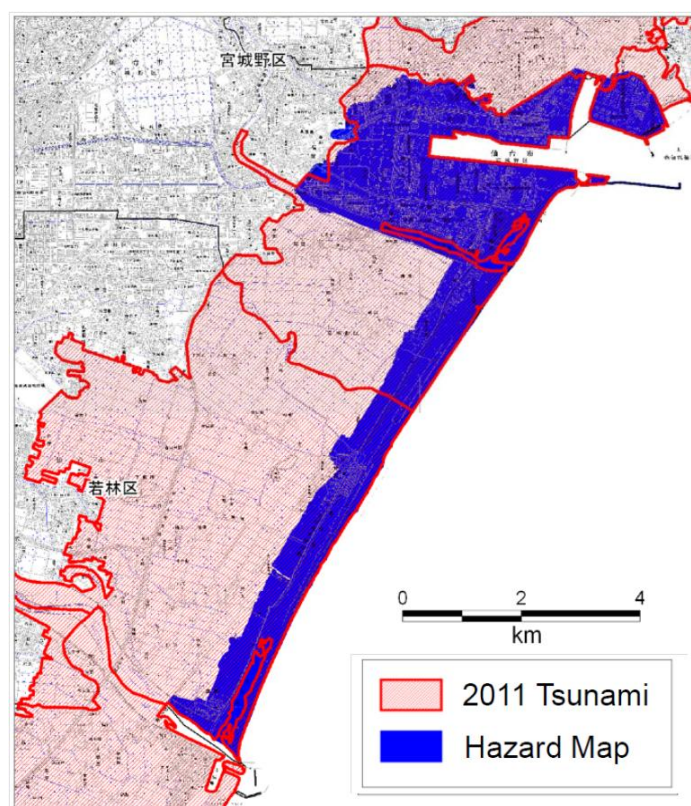
underestimated, and Fig. 6.31 shows a comparison of inundation areas according to the hazard map and actual affected areas.

Fig. 6.31 Sendai tsunami inundation hazard map (Koshimura, 2012)

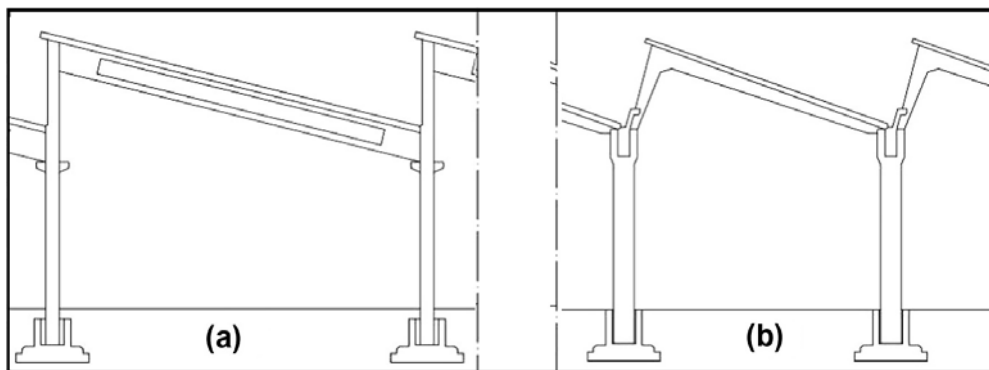
the Emilia Romagna earthquakes were due to low longitudinal reinforcement ratio, large spacing of stirrups, weak column pocket sockets and irregularities such as adjacent stiff members or partly infilled walls. Regarding short-column formation, one observation of Liberatore et al. (2013) deserves special attention. The sawtooth type of roofing with inclined beam system is prone to short column formation due to a sudden change of stiffness at lower beam-column connection (Fig. 7.15a) whereas knee portals illustrated in Fig. 7.15b do not have such a weakness (Liberatore et al., 2013). Common damage to beam and roof elements occurred because of either unseating of these members or pounding with adjacent structural elements. Additionally, an insufficient diaphragm effect and individual column footings are other factors that contributed to the structural damage.

Fig. 7.15 Inclined beam (a) and knee portal (b) sawtooth roofs (Liberatore et al., 2013)

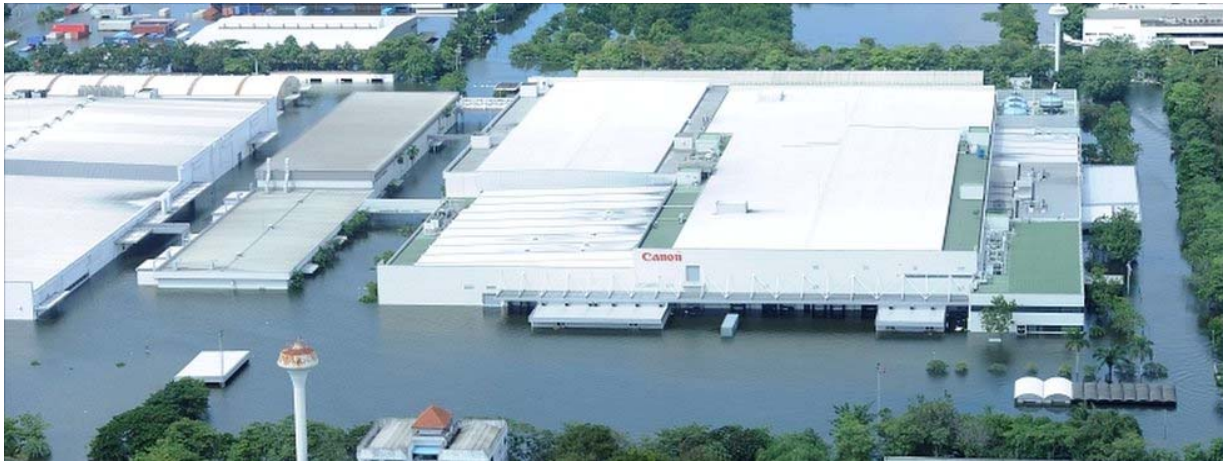
Damage to the industrial sector was extensive and severe due to the inundation height and the duration of the flood. Van Oldenborgh et al. (2012) stated that some industrial regions experienced more than 2.5 m inundation level for 2 months (see Fig. 7.16). The water entered the industrial sites when embankments were overtopped or breached, or via discontinuities in retaining walls.

Fig. 7.16 Inundation level at industrial estates near northern Bangkok³
